August 28, 2024

**SUBJECT: EVALUATION SUMMARY OF EXISTING OUTDOOR SWIMMING POOL FACILITY**

**PROJECT: BERLIN FAMILY AQUATIC CENTER  
BERLIN, WISCONSIN  
RAMAKER & ASSOCIATES PROJECT #60575**

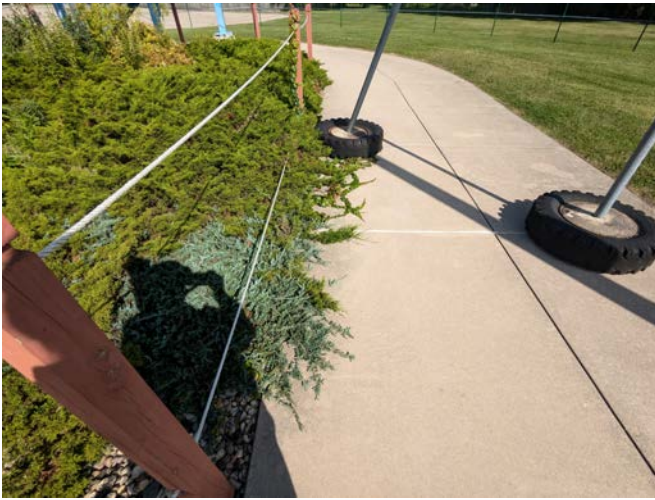
1. Pool Area Deck: Overall good condition, one crack noticed at the base of the diving board. There is landscaping that is growing onto the pool deck under the waterslide. This should be trimmed back to not cover the deck walkway. Continue maintenance as normal. See photo 03.

3. LANDSCAPING OVER THE POOL DECK

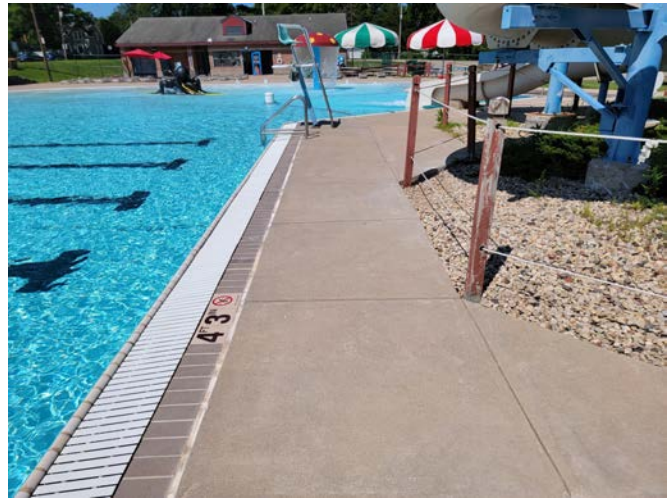
2. Pool Deck Width: According to the Wisconsin pool code, pool deck must extend at least six feet from all basins. The deck between the pool vessel and the edge of the slide area is only 5'-8" wide. See photo 04. Additionally, there is landscaping under the waterslide that does not have a 4" depression that is required between the pool deck and the landscaping grade according to code. This was likely code compliant when first installed but should be renovated to achieve the 4" difference again.

4. POOL DECK ONLY 5'-8" WIDE.

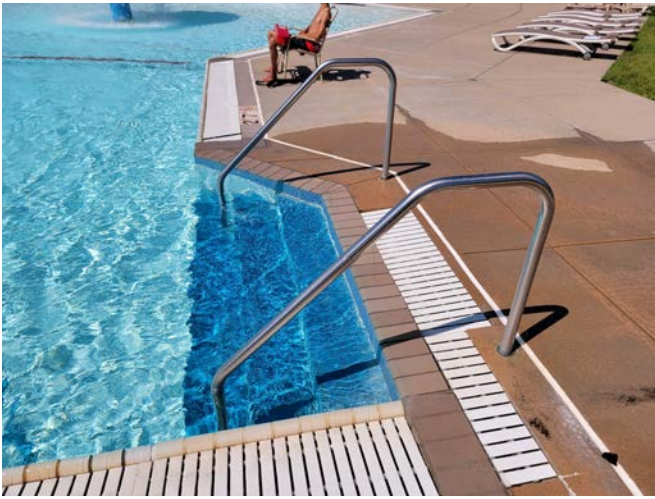
6. Pool Stairs: There is one set of stairs into the slide plunge area that appear to be in good condition. The handrails are 2'-9.5" tall and 5'-10.5" apart with minimal corrosion. Code requires that the leading edge of all steps be distinguished by a color contrasting with the color of the steps and pool floor. When the pool is refinished, this stripe should be added as well. Continue maintenance as required. See photos 05.

5. POOL STAIRS

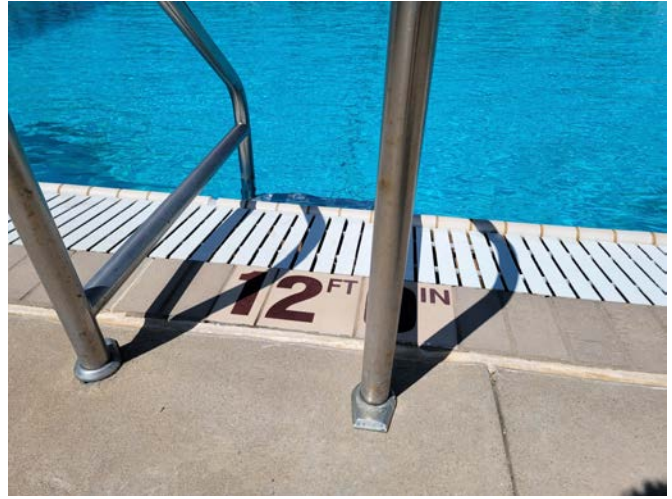
7. Pool Access Ladders: There are seven sets of access ladders, with one located in the middle of the diving hopper on the east end of the vessel. There is slight corrosion on the east dive hopper ladder and on the south shallow side ladder. See photos 06.

6. CORROSION ON POOL LADDER

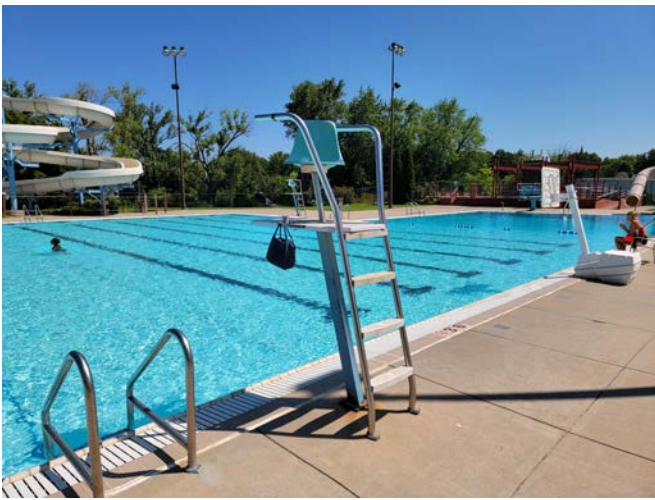
8. Lifeguard Chairs: There are four stationary chairs, and two portable chairs around the vessel. There was corrosion observed on all the lifeguard chairs to some degree, but they are otherwise in good condition. There is a broken support on the lifeguard chair on the east side of the lap lane area. The corrosion on each lifeguard chair should be treated as needed. Chairs that can't be repaired should be replaced to avoid failure in the future. See photos 07, and 08.

7. TYPICAL LIFEGUARD CHAIR

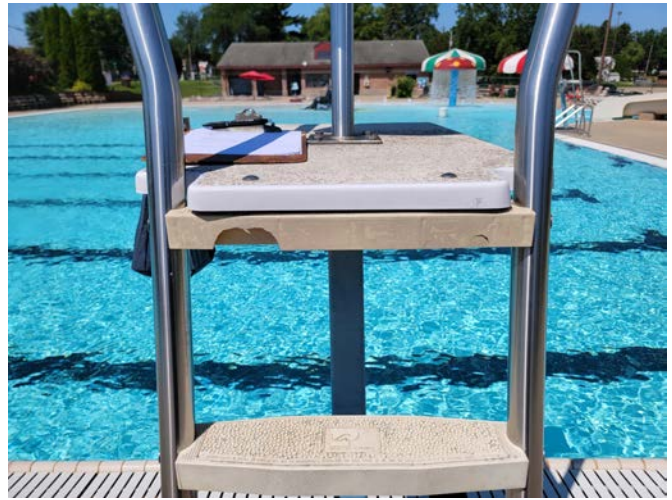
8. BROKEN SUPPORT ON LIFEGUARD CHAIR

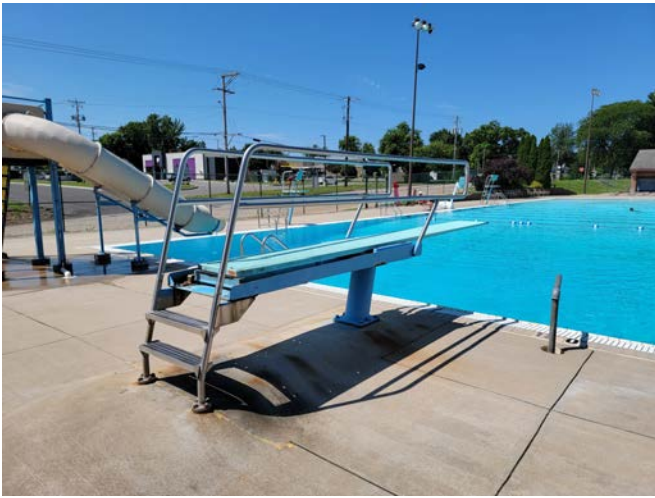
9. Diving Board: There is one 1-meter diving board into the dive hopper and there is significant corrosion present. This corrosion should be removed with a wire brush and refinished. Parts of the diving board that can't be repaired should be replaced to avoid failure in the future. A new diving board stand that is not like for like with the existing diving board, will require DSPPS submittal. The decking around the diving board is cracked and should be monitored and maintained as needed. See photos 09, 10, and 11.

9. DIVING BOARD

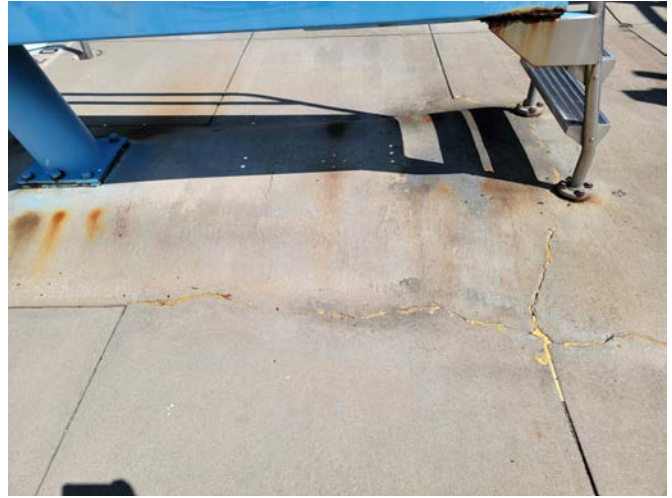
10. CRACKING AROUND DIVING BOARD BASE

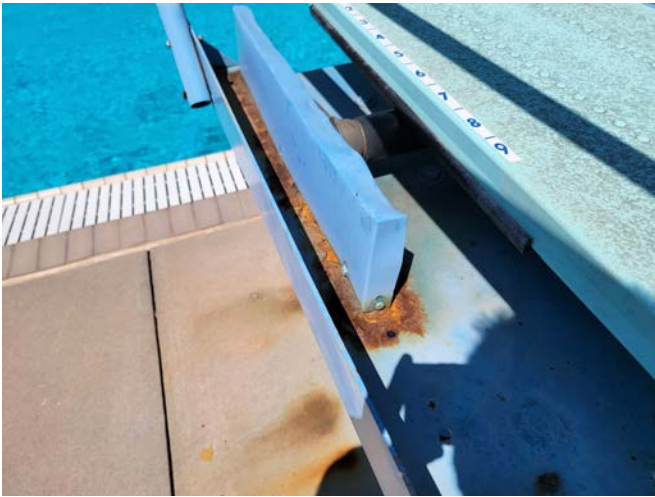
11. CORROSION ON DIVING BOARD ASSEMBLY

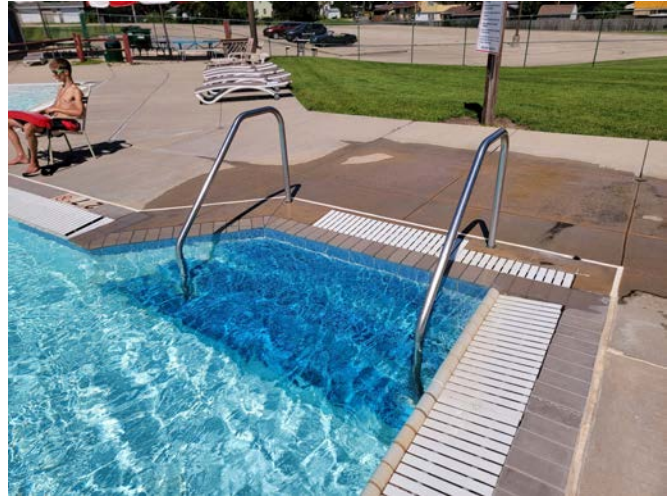
- Slide Plunge Area – Starting approximately 10-12 years ago, Berlin noticed that they were losing water over the edge of the pool by the stairs into the slide plunge area. Berlin expressed that the water loss has increased in the past five years. During the visit it was clear to Ramaker that some sinking had occurred in that corner of the vessel. During the second visit Ramaker observed large cracks in the gutter on either side of the slide plunge area indicating that this area has settled. It appears that the slide plunge area is the only part that is sunk. However, before repairs are made, a survey of the empty vessel will need to be conducted to accurately determine the bounds of reconstruction. To reduce water loss during use, the operators of the facility lowered the water level in the vessel during the time of the visit. Ramaker was unable to determine if other areas of the pool were impacted due to inconsistent rim flow over the gutter around the pool perimeter.

10. Slide Plunge Area: The slide plunge area shows signs of sinking with water running over the gutter by the stairs and onto the deck behind it. Further investigation is needed to determine the extent of the sinking in this corner. It is possible that the entire northern section of the pool from the zero-depth entry to the slide plunge has sunk. It appears that the northern section of the zero-depth entry is lower than the section adjacent to it. The nearby deck sections don't show any signs of cracking or strain. During the second site visit cracks in the gutter were observed on either side of the slide plunge area indicating settling. See photos 12, 13, 14 and 15.

12. WATER OVERFLOWING THE POOL STAIRS

1. Sunken Slide Plunge Area (approximately 600 square feet)
  - a. Ramaker recommends that a survey of the pool basin be completed to determine the bounds of the sunken portion of the pool vessel.

- b. From there, the sunken area should be demolished and replaced to make sure that the gutters and basin floor are in the correct position.
  - c. Ramaker also recommends ground penetrating radar (GPR) be performed to verify that there are no voids occurring under other parts of the pool basin.

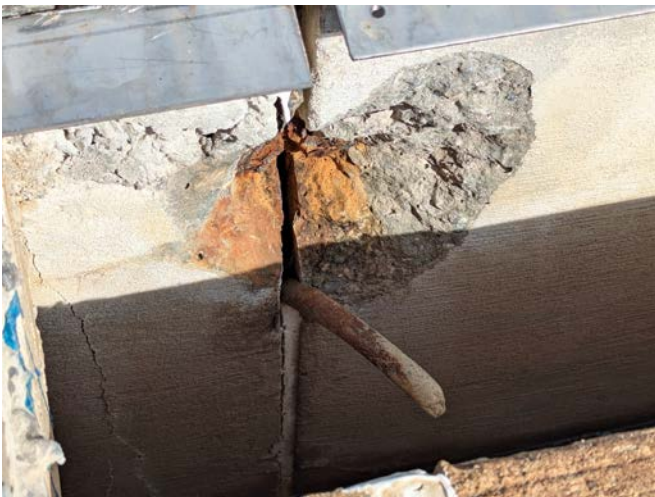
13. BROKEN GUTTER JOINT

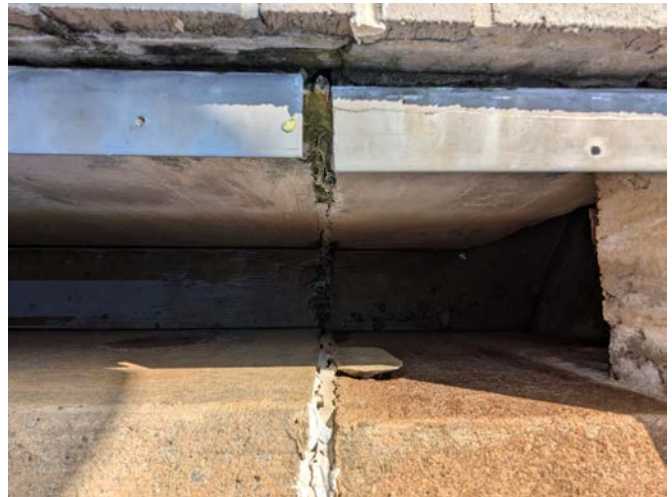
14. BROKEN GUTTER JOINT

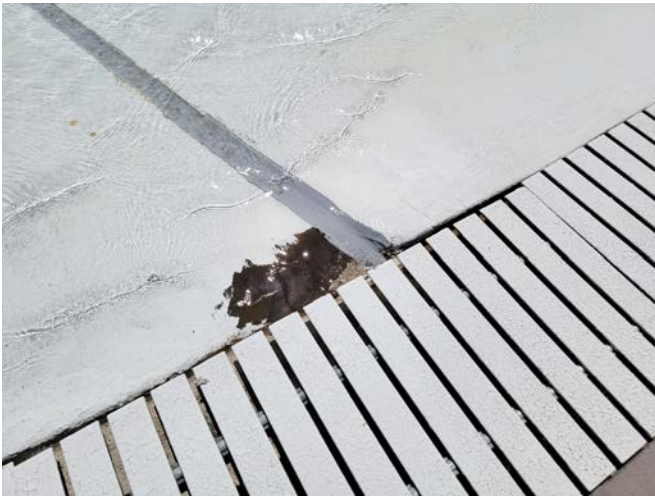
15. NORTHERN SECTION APPEARS LOWER

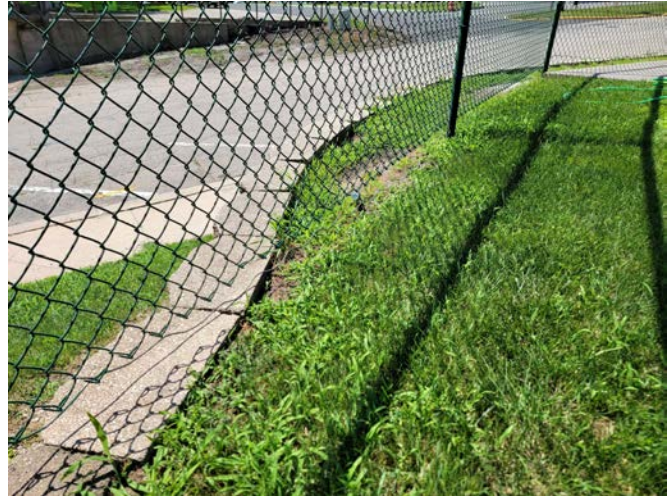
11. Pool Enclosure: The facility is surrounded by chain link fencing along the entire perimeter. There are gaps larger than 4" observed in several locations specifically on the southeast corner of the enclosure. The fencing should be repaired so that there are no gaps larger than 4" to meet pool code requirements. See photo 16. Update photo callout.

16. GAP UNDER FENCING LARGER THEN 4"

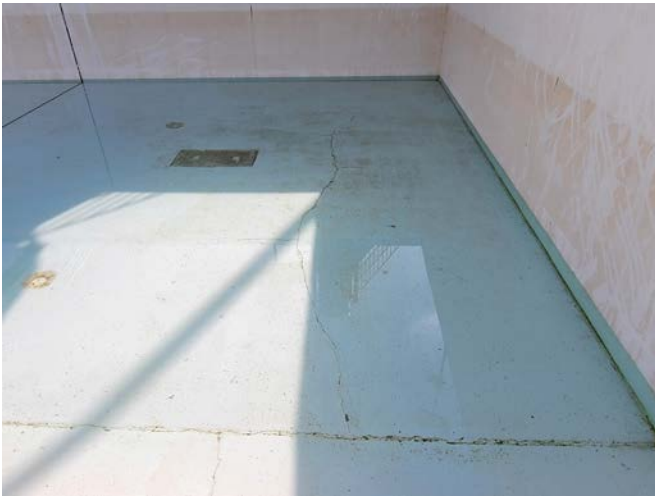
A significant effort has been put forth to keep this pool functional throughout the years. There are numerous surface cracks that were observed in the pool basin and the finish should be redone as it is flaking off in places around the pool vessel. See photos 17, 18, and 19.

17. CRACK IN DIVING HOPPER

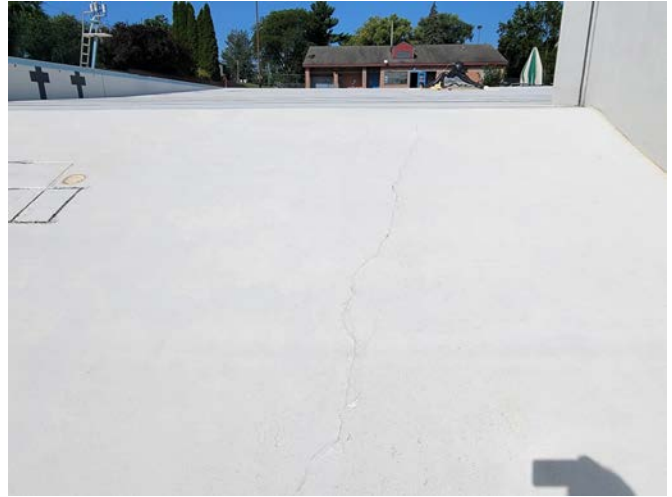
18. CRACK ON TRANSITION PANEL

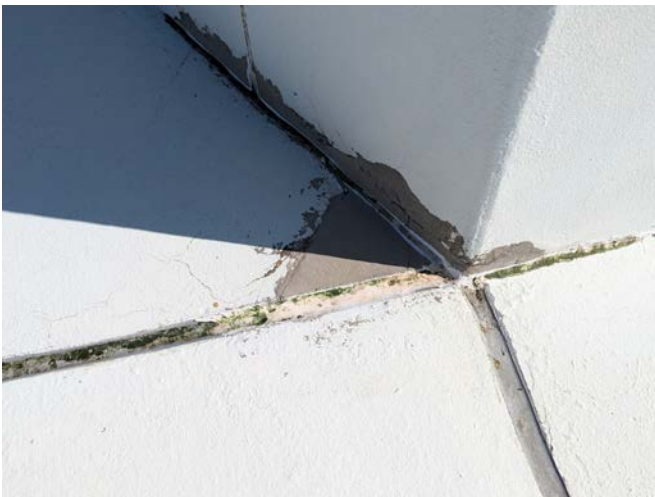
19. FINISH IS COMING OFF THE FLOOR

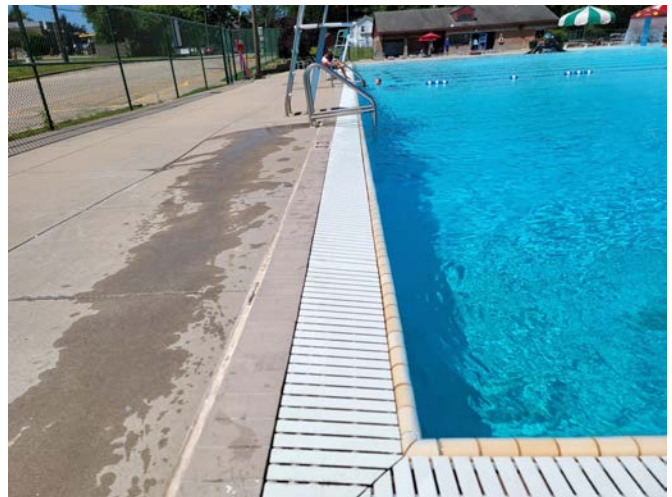
2. Pool Perimeter Overflow Gutter: The gutters physically looked to be in good condition except around the slide plunge area. As stated above, there were places on either side of the waterslide that were cracked. The bullnose piping that is used on the gutter rim is outdated and has been discontinued. There are areas where the bullnose has been broken and has been replaced with PVC pipe as a stopgap measure. Some tiles are missing altogether. Broken and missing tiles can result in sharp edges around the pool. Additionally, the operators reduced the water level in the pool to minimize water loss in the slide plunge area which led to improper rim flow over the majority of the pool perimeter. Ramaker recommends replacing the bullnose tile completely. See photos 20, and 21.

20. NO RIM FLOW OVER GUTTER

- a. The bullnose tile and waterline tile around the entire perimeter of the pool should be replaced as the current bullnose tile is obsolete and Berlin can't obtain anymore to help with repairs.

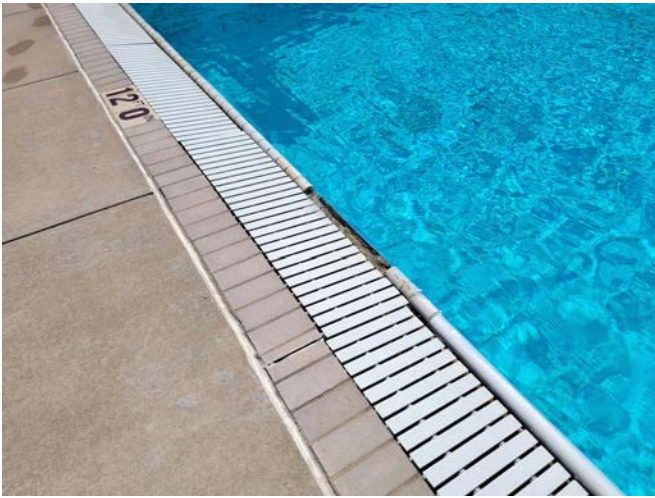
21. BROKEN GUTTER BULLNOSE

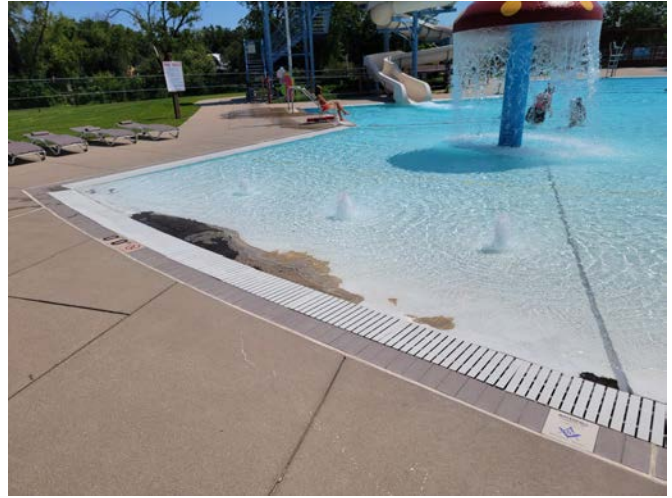
5. Basin Shell: Pool finish consists of painted concrete. The vessel was last painted 15 years ago and there are areas in the zero depth basin where the paint has flaked off exposing the concrete. Ramaker recommends repainting the areas as needed. See photo 22.

22. FINISH FLAKING OFF IN ZERO DEPTH AREA

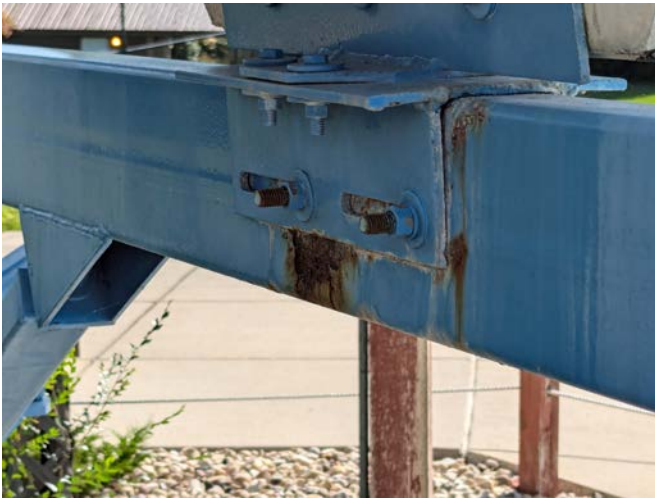
1. There are some spots of corrosion on the support structure that should be treated with a wire brush and have the finish reapplied. See photo 23.
2. There is corrosion present on some of the bolts on the structural as well. These bolts should be treated to remove the corrosion. Bolts that can't be treated should be replaced. See photo 24.
3. There are bolts outside the roped off area that don't have covers and could injure patrons passing by. All bolts within arm's reach should be covered to prevent this. See photo 25.

23. SUPPORT CORROSION

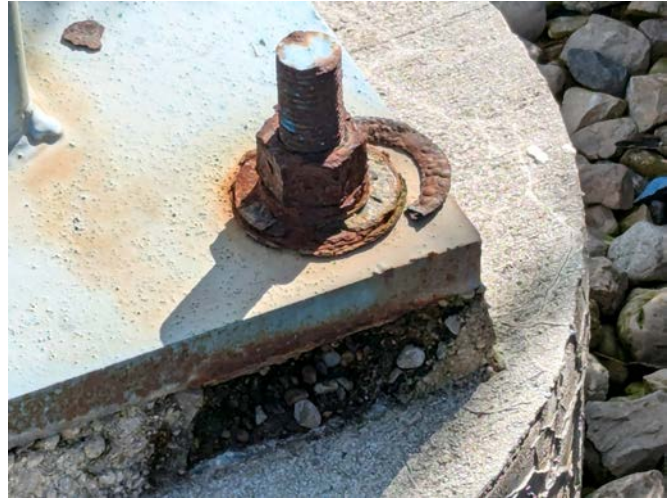
24. CORRODED BOLTS

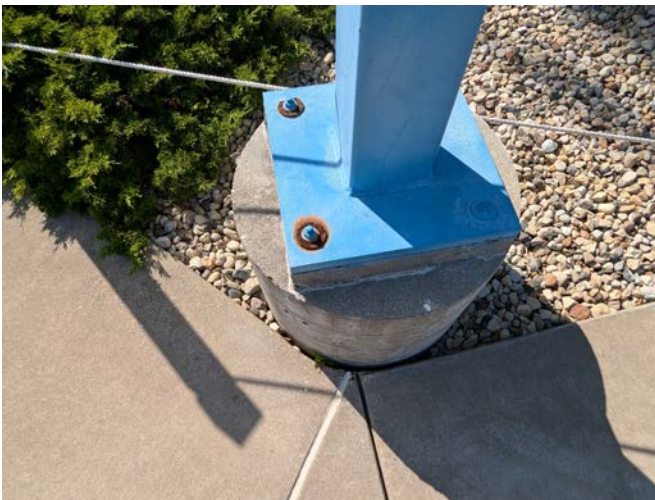
25. EXPOSED FASTENERS OUTSIDE OF BARRIER

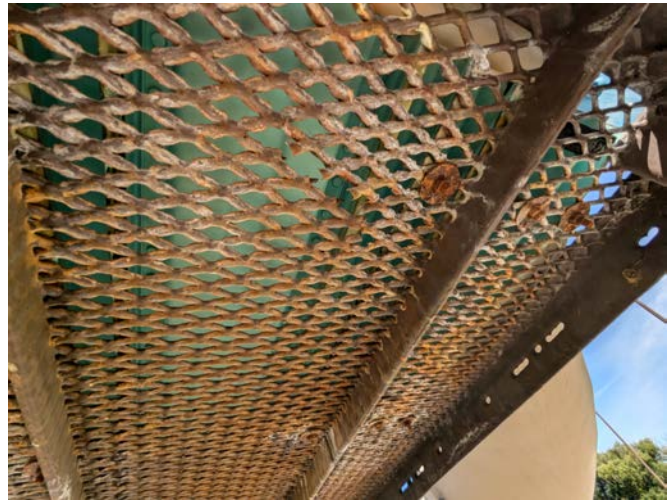
1. There is significant corrosion underneath the starting platform. This should be removed with a wire brush and then refinished. If this cannot be treated, the landing should be replaced. See photo 26.
2. Currently the stairs to the drop slide don't meet building code requirements and are grandfathered in. If the slide is removed, it will not be able to be reinstalled with the current stairs.

26. CORROSION UNDER DROP SLIDE PLATFORM

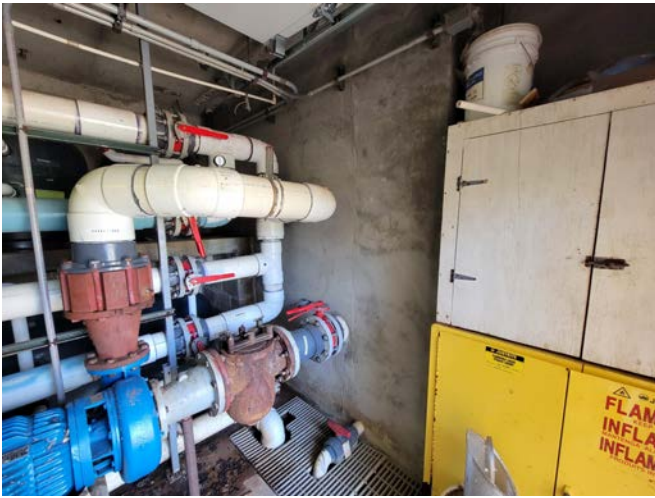
1. Overall, the surge tank appears to be in relatively good condition. No cracks in the tank walls, or leaks were noted. Continue maintenance as required.
2. The tank is supplied water from the pool perimeter gutter. The recirculation pump draws directly from the tank with no connections to the pool basin. See photo 27.

27. SURGE TANK IN MECHANICAL ROOM

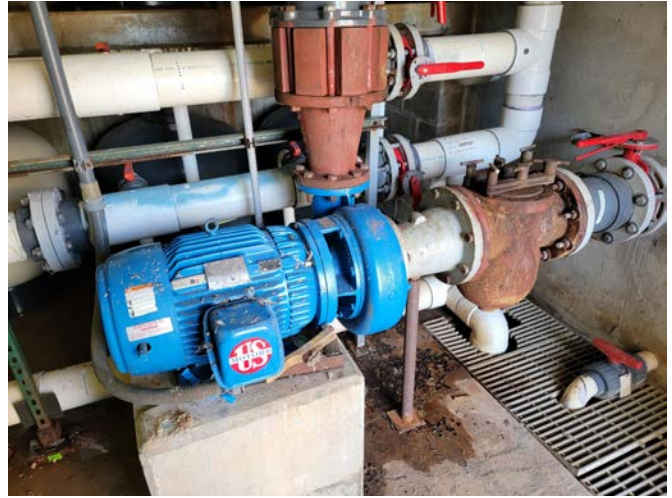
- *Recirculation Pump:* One 30 HP pump with some slight corrosion. Heavy corrosion on the reducers out of the pump and on the strainer. Aurora AS08-07144, 5X6X11, 341-BF, 1250 GPM @ 80 TDH, 1800 RPM. See photo 28.

28. CORROSION ON RECIRCULATION PUMP ASSEMBLY

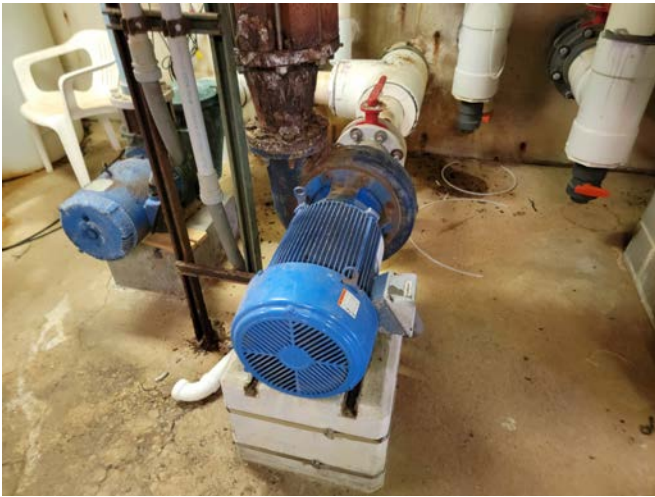
- *Waterslide Pump:* One 20 HP pump with some slight corrosion. Heavy corrosion on the reducers out of the pump and on the strainer. Aurora AS-09-12687, Model 5X6X11 - LB, 341-BF, 1000GPM @ 40 TDH, 1800 RPMs. See photo 29.

29. CORROSION ON WATERSLIDE PUMP ASSEMBLY

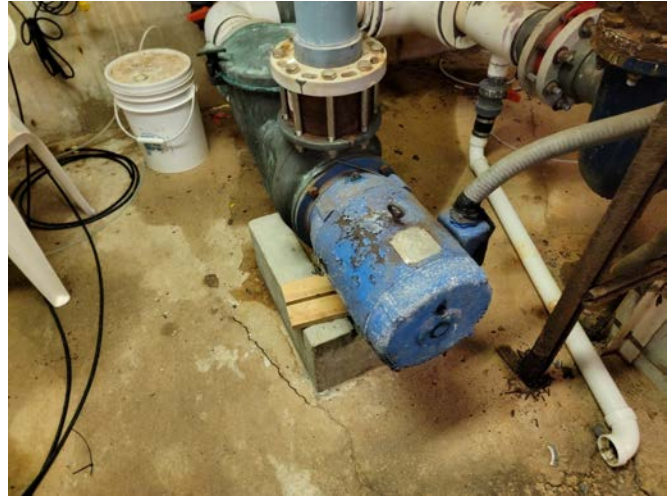
- *Water Feature Pump:* One 15 HP pump with some slight corrosion. Heavy corrosion on the reducers out of the pump. See photo 30.
- *Filter:* There are five Pentair Triton TR-140 filters and seven Astral Pool filters Model 27857 configured in a concrete shelf system with six on top and six on bottom. This configuration is likely not code compliant. The recirculation rate of the pool is 1250 GPM which requires 104.2 GPM per filter for equal flow. With the Astral filter areas at 6.84 square feet, they configuration can only supply 102.6 GPM maximum per the code required 15 GPM/square foot. The Astral filters should be replaced with Triton TR-140s to achieve balanced filtration. New, larger filters could be installed, but more of the equipment room would need to be redone to accommodate them. The filters appeared to be in good condition, however, some of the filters were leaking from their drain locations on bottom. See photo 31.

30. CORROSION ON FEATURE PUMP ASSEMBLY

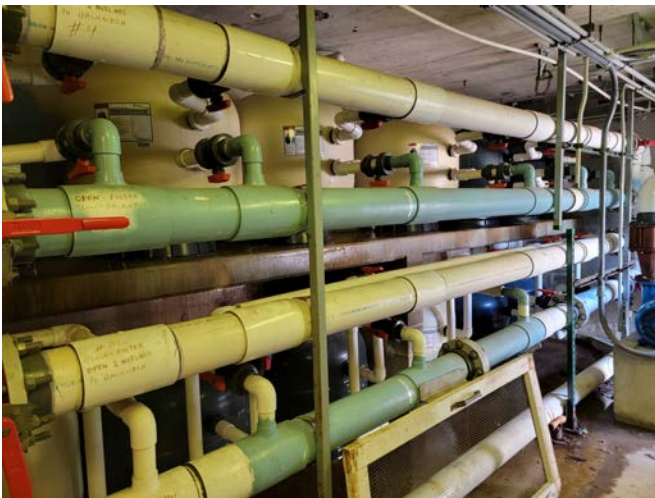
31. FILTER ASSEMBLY

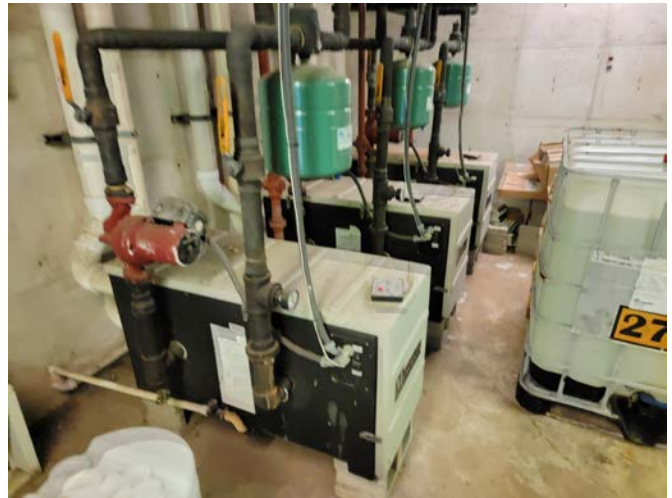
- *Pool Heat Exchangers:* There are three boilers that appear to be in good condition and are connected to two heat exchangers that is heating the pool. See photo 32.

32. THREE BOILERS

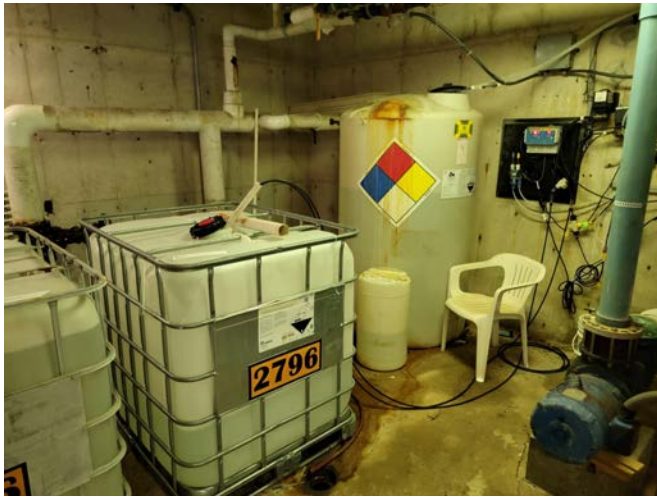
- *Chemical Feed Equipment:* Liquid chlorine and acid are located in the same space as the rest of the mechanical equipment. See Photos 33.

33. CHEMICAL FEED EQUIPMENT

2. Chemical Rooms
  - a. Ramaker recommends installing two chemical rooms in the mechanical space to isolate the chemicals from the rest of the equipment and reduce the amount of corrosion.

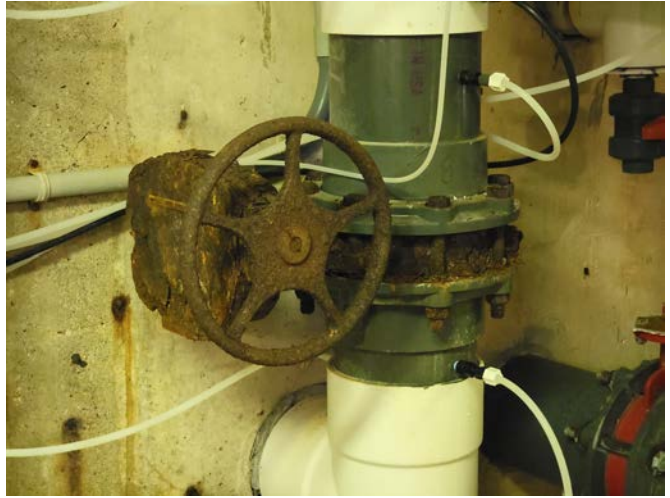
Visually there is severe corrosion present on all metal components in the mechanical room. The corrosion should be removed as necessary and equipment that can't be treated should be replaced as needed. See photos 34, and 35.

34. CORRODED VALVE

3. Corroded Metal Components in the Mechanical Room
  - a. Ramaker recommends that all metal components showing signs of corrosion be replaced. This includes but is not limited to the following:

- i. Electrical boxes and panels.
    - ii. Water supply piping for the bathhouse.
    - iii. Metal piping out of the pumps.
    - iv. Pipe hangers.
4. Replacement of bullnose tile

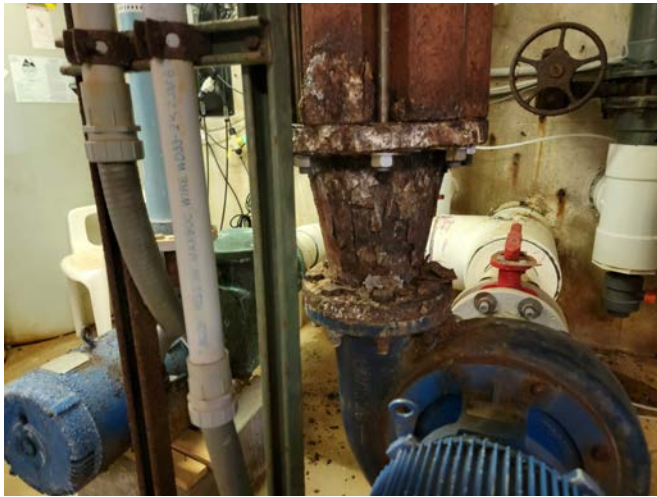
35. HEAVILY CORRODED REDUCER

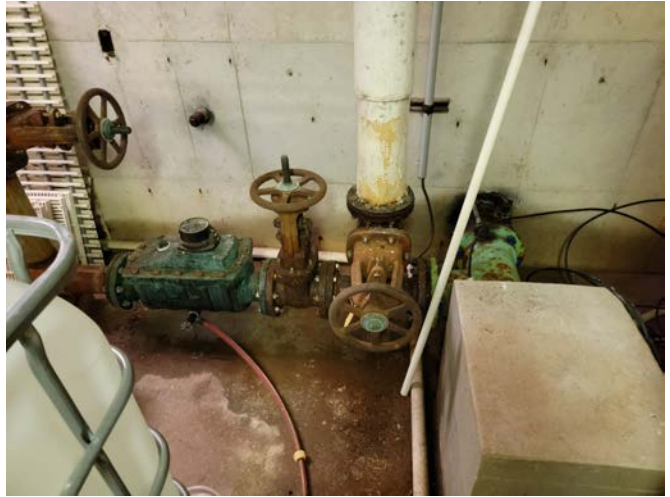
The supply water assembly train is located behind the chemical storage tanks in the mechanical space and is severely corroded. This should be replaced to prevent the system from failing. See photo 36.

36. CORRODED BATHHOUSE WATER TRAIN ASSEMBLY

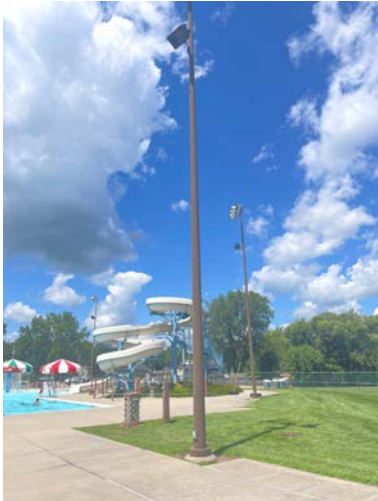
The pool facility has six light poles around the pool vessel that provide illumination for nighttime swimming. The light poles appear to be in good condition and Berlin staff desires to update the lighting to LED bulbs. For outdoor facilities according to DSPS code, the lighting shall provide a minimum of 3 footcandles of illumination at the water surface and on the decking. See photo 37.

37. POOL AREA LIGHT POLE

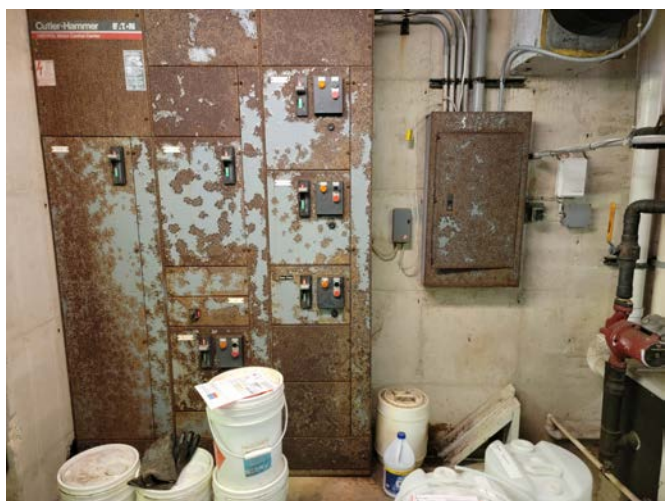
The entire electrical system for the pool facility is located in the pool equipment room below the pool deck. Due to proximity to the chemicals, there is severe corrosion present on the panels and boxes. See photo 38. No concerns were expressed to Ramaker by facility managers at the time of site visit. Continue to monitor and maintain electrical systems to ensure all equipment functions as needed when required.

38. CORRODED ELECTRICAL SYSTEM IN MECH ROOM

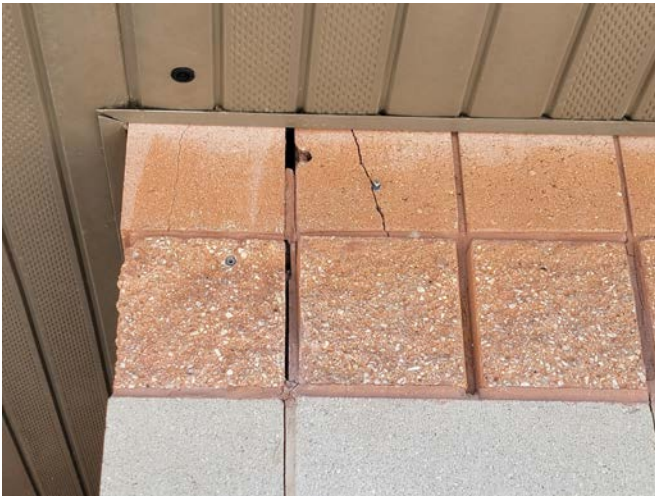
The Concrete Masonry Unit (CMU) walls of the building's exterior and interior are in good condition with no major structural deficiencies observed. There are a couple cracks at the exterior CMU with some separation at the mortar joints, see photo 39. There are instances of mineral deposits on the CMU below water bibs, see photos 40, 41, and 42.

39. CRACKS AND SEPARATION OF CMU

6. Building Exterior
  - a. CMU cleaning at hose bibs.
  - b. Repointing CMU at cracks and replacing broken glass block.
  - c. Wood material will need typical wood maintenance, such as cleaning, replacing boards as needed, prepping for finish, and applying a finish.

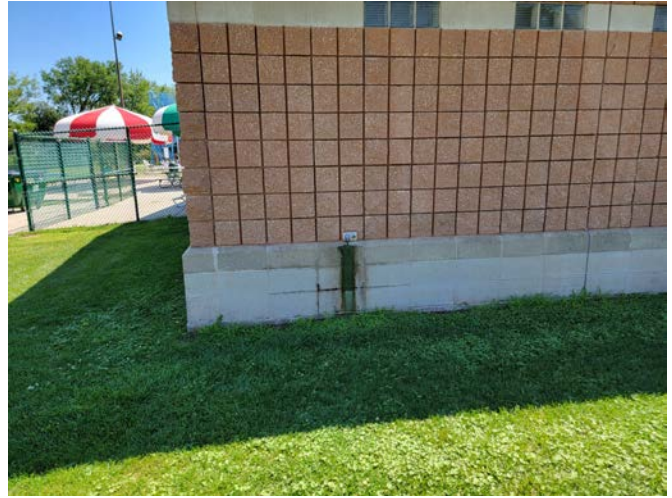
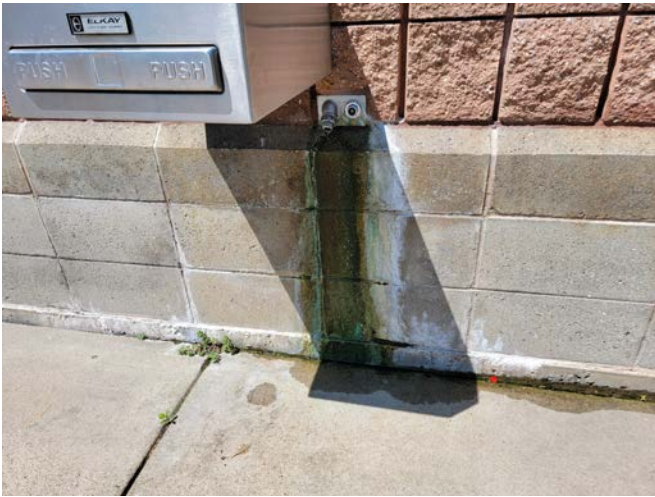
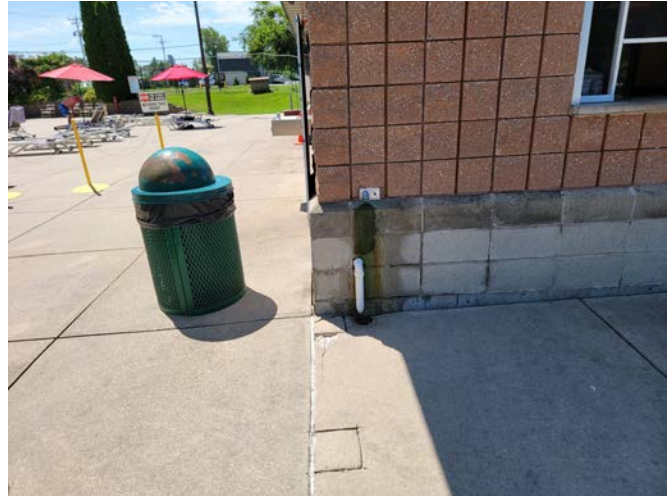
40. MINERAL DEPOSITS AT WATER BIB

41. MINERAL DEPOSITS AT WATER BIB

42. MINERAL DEPOSITS AT WATER BIB

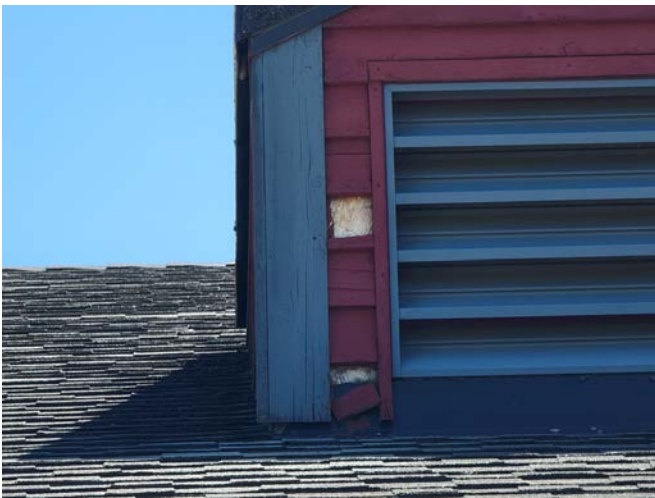
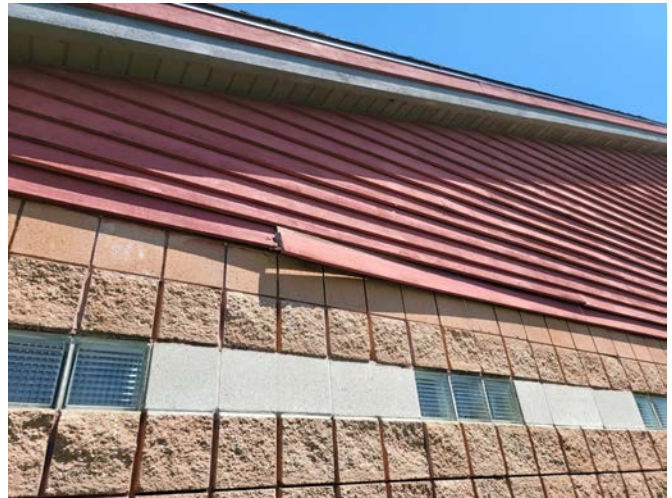
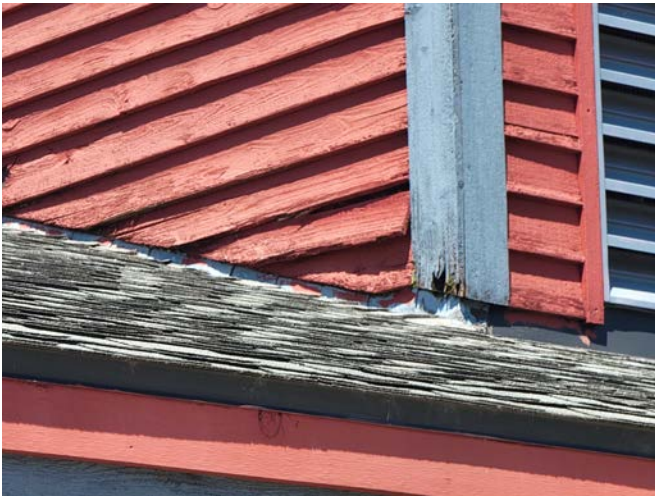
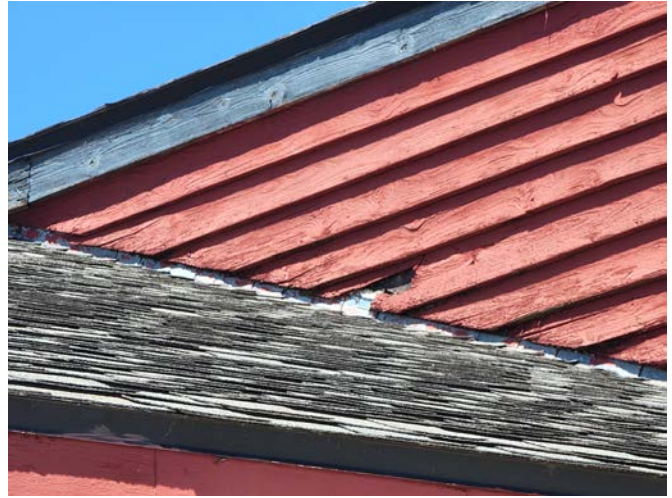
The wood siding above the CMU appears to be in fair condition with a couple instances where the siding is deteriorating and not attached correctly or missing, see photos 43, 44, 45, and 46. The wood fascia board has areas where the wood is also deteriorating, see photos 47, 48, and 49. The paint is peeling at the Men's and Women's poolside entrance soffit. Wood siding, wood fascia boards and wood soffits will need continued typical wood maintenance of cleaning, replacing boards as needed, prepping for finish, and applying a finish.

43. MISSING WOOD SIDING

44. WOOD SIDING NOT ATTACHED

45. WOOD SIDING DETERIORATING

46. WOOD SIDING DETERIORATING

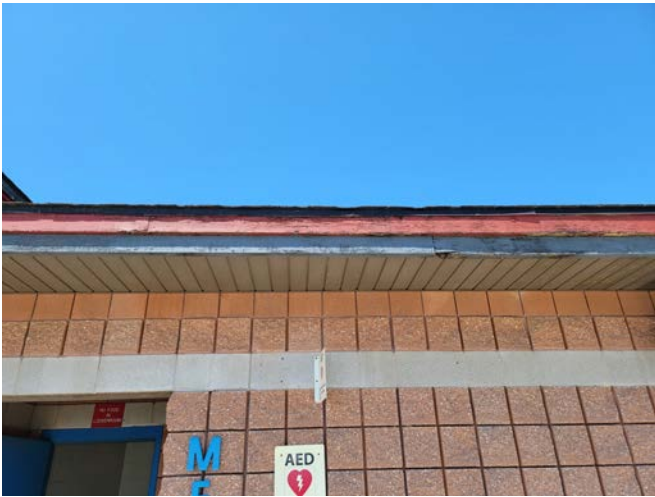
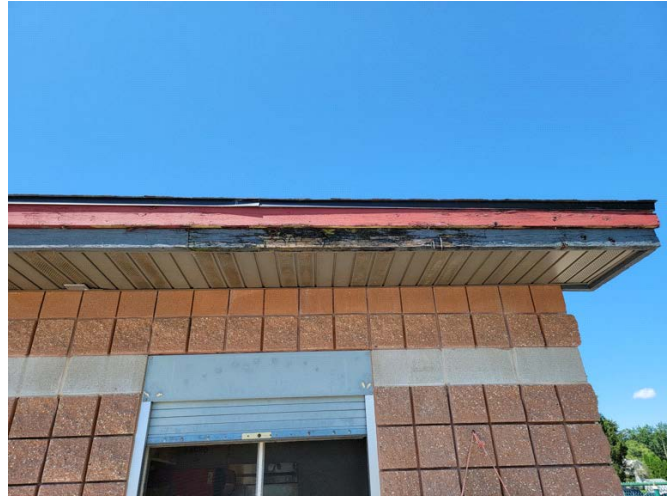
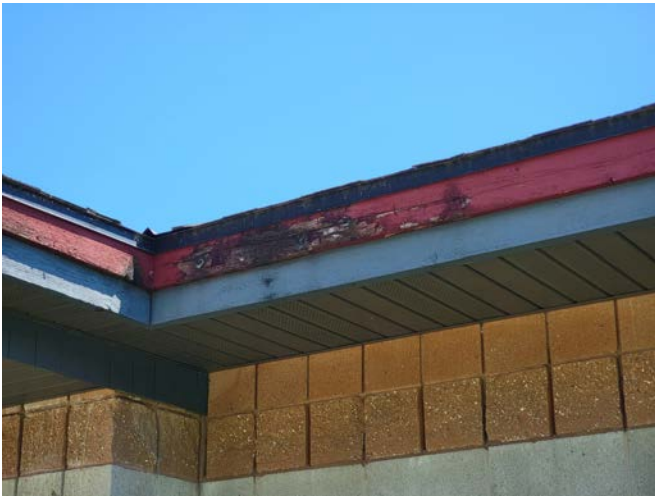
47. WOOD FASCIA BOARD DETERIORATING

48. WOOD FASCIA BOARD DETERIORATING

49. WOOD FASCIA BOARD DETERIORATING

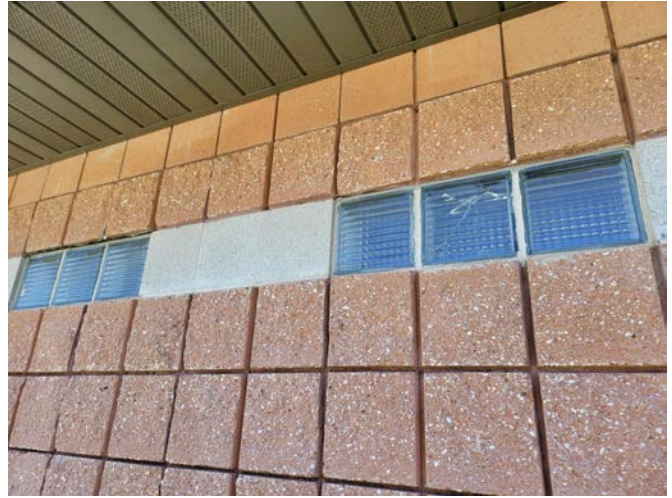
The exterior doors have some rust at the bottom of the doors and frames but otherwise seem to be in good condition. There are glass block windows in the exterior masonry wall with one broken glass block, see photo 50. The louvers throughout need cleaning. The AED cabinet is corroding along with a couple lintels, see photos 51 and 52.

50. BROKEN GLASS BLOCK

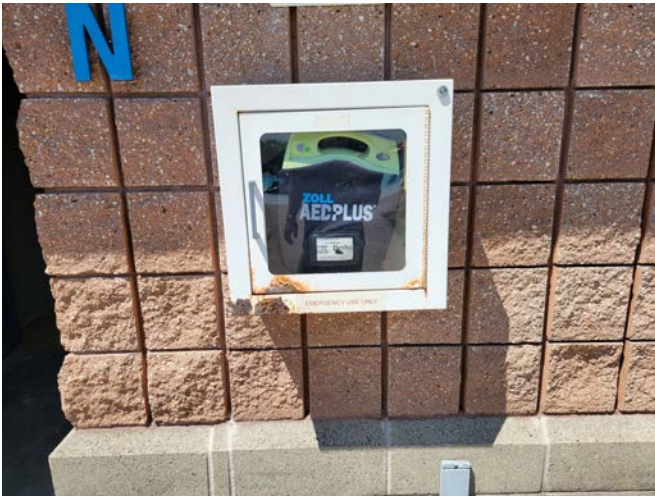
51. CORRODED AED CABINET

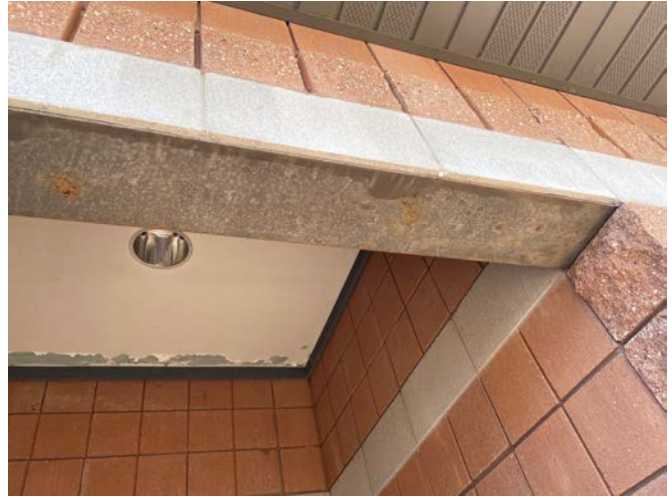
52. CORRODED LINTEL

- d. Steel lintels should be cleaned, prepped for new finish and finished.
7. Building Interior
  - a. CMU cleaning throughout the building interior.

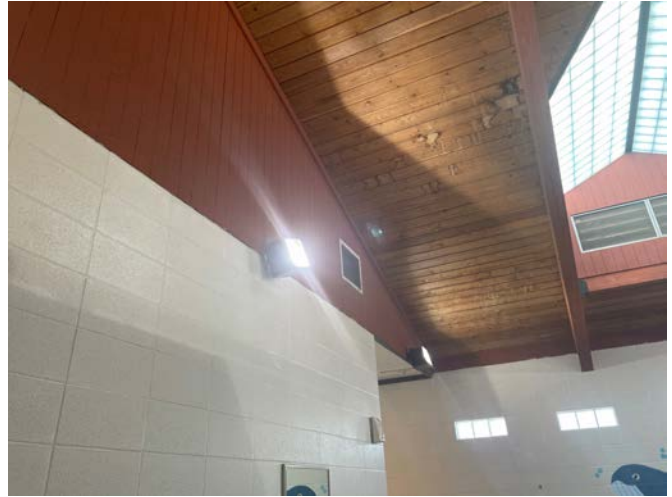
54. DISCOLORATION AROUND SKY LIGHT

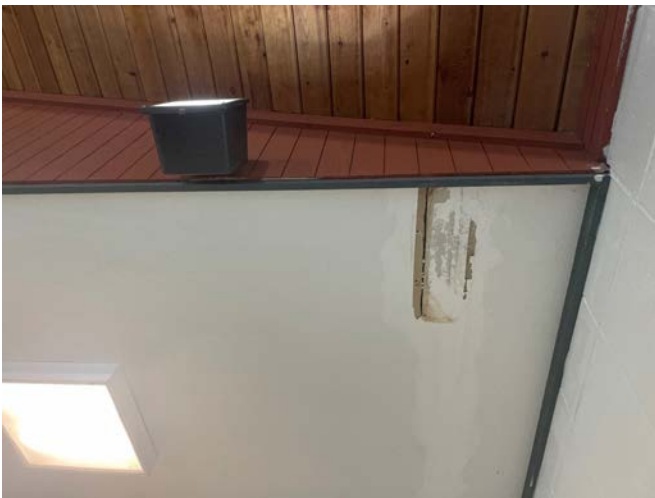
55. DAMAGED CEILING AT MEN'S LOCKER ROOM

- b. Damaged ceiling at the men's locker room should be repaired and further investigated to the cause of the damage.
- c. The countertop in the women's locker room should be relaminated or replaced.
- d. Door hinges at the mechanical room should be replaced with offset door hinges to gain the width of the door for removing equipment. If more room is desired the three doors and frames may need to be removed along with adjacent CMU wall as needed and replaced with three larger doors and frames.
- e. ADA-related items should be addressed as feasible. Minor items may be addressed as part of routine maintenance, whereas larger items may be addressed as a part of a larger renovation project. A Transition Plan should be established to document the intent to bring the facility into compliance as well as plan the best course of action.

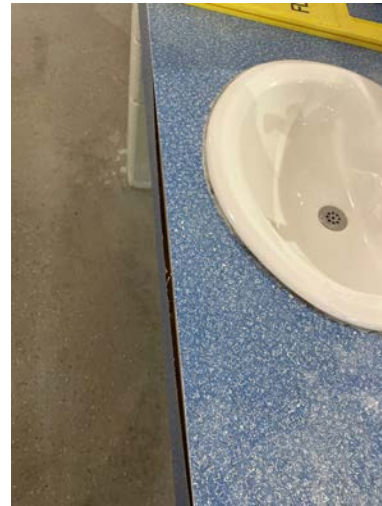
The floors throughout the bathhouse locker room and staff rooms are epoxy finished concrete, with signs of wear and tear. There is a significant crack observed at the women's poolside entrance, see photo 53. The CMU walls on the interior are painted and have mineral deposits and dirt built up throughout and towards the bottom. The wood wall finish above the CMU walls and wood ceiling boards are in good condition with some discoloration around the sky light. This may be an indication that there is or was water leaking, see photo 54. The painted ceilings in the Men's locker room show signs of damage and was repainted at some point, see photo 55. The countertop in the Women's locker room is delaminating, likely due to the presence of moisture, see photo 56.

56. DELAMINATING COUNTERTOP AT WOMEN'S LOCKER ROOM

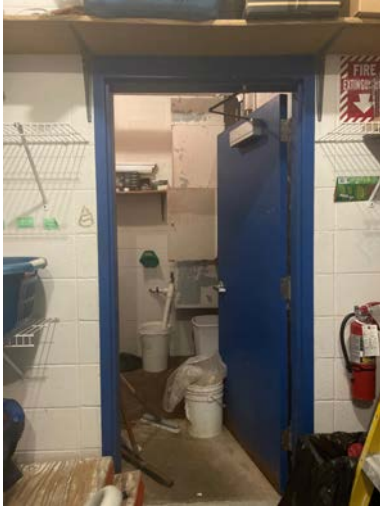
The equipment in the mechanical room is difficult to get in and out for winterization. There are three single flush doors for equipment to travel through, see photos 57 and 58. The door hinges could be replaced with offset door hinges to increase the width of the door.

57. MECHANICAL ROOM DOOR
