August 28, 2024

**SUBJECT: EVALUATION SUMMARY OF EXISTING OUTDOOR SWIMMING POOL FACILITY**

**PROJECT: BERLIN FAMILY AQUATIC CENTER  
BERLIN, WISCONSIN  
RAMAKER & ASSOCIATES PROJECT #60575**

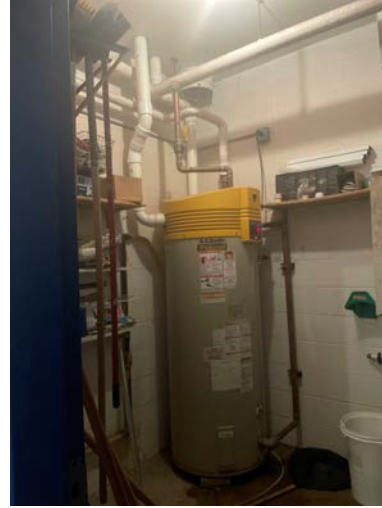
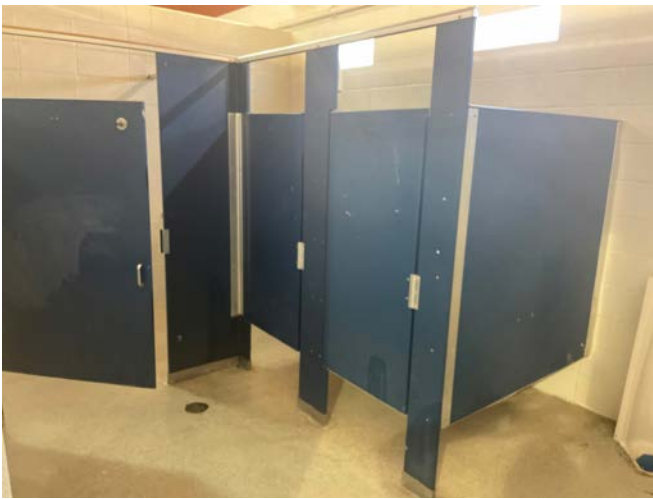
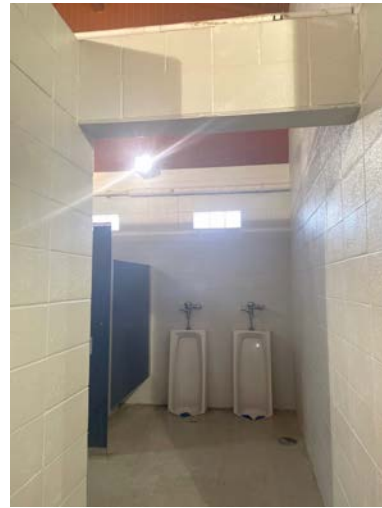
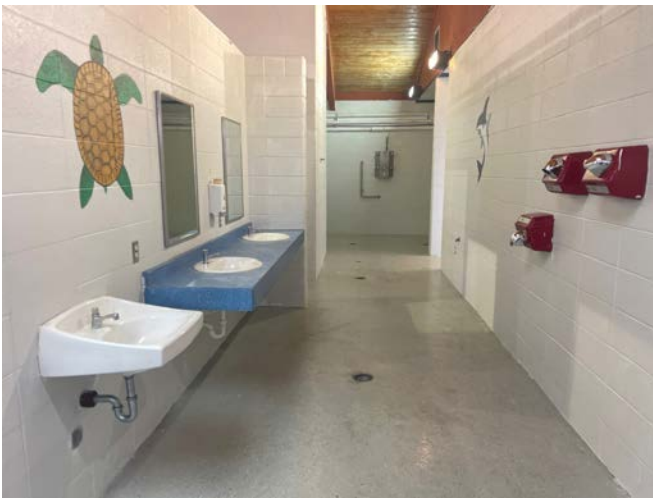
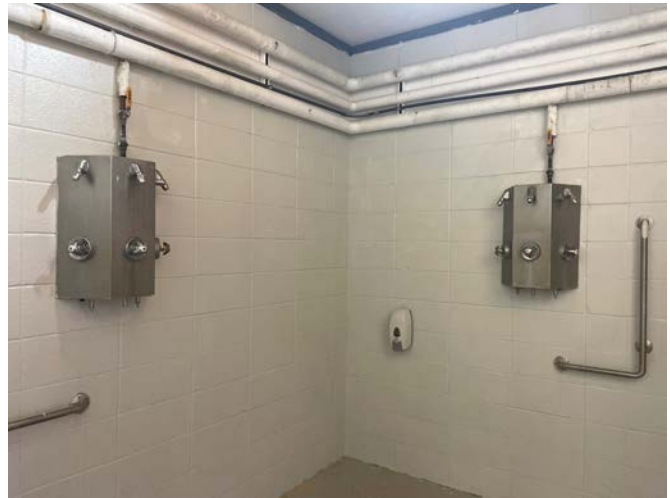
3. The Men's locker room is not fully ADA compliant. Towel hooks and shower controls are not within reach ranges. There is exposed abrasive plumbing below the lavatories. The accessible toilet is not the correct distance from the wall, the toilet seat is too high, the flush valve is on the wrong side, and missing a vertical grab bar. There is no accessible shower or changing room available.

58. MEN'S URINALS

59. MEN'S WATER CLOSET COMPARTMENTS

60. MEN'S URINALS

61. MEN'S LAVATORIES

62. MEN'S GANG SHOWERS

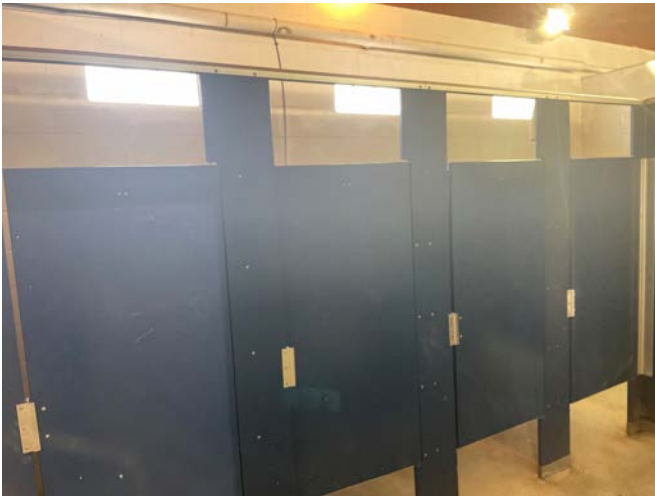
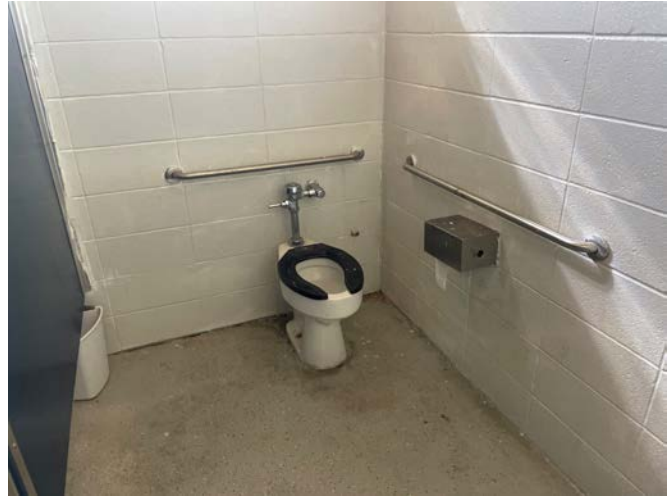
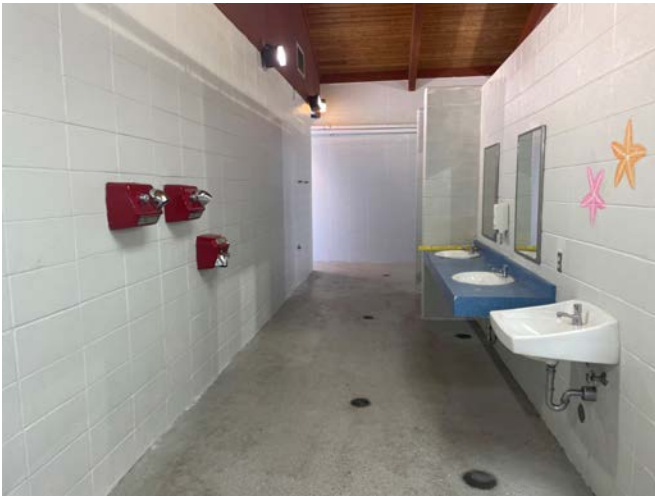
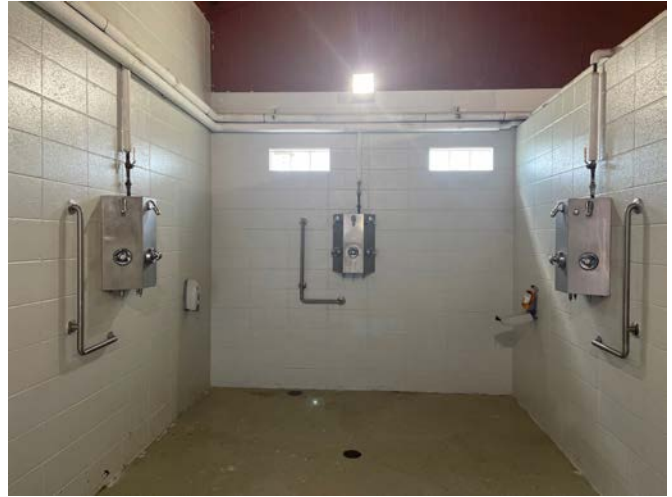
2. The Women's locker room is not fully ADA compliant. Towel hooks, soap dispenses, and shower controls are not within reach ranges. There is exposed abrasive plumbing below the lavatories. The accessible toilet is not the correct distance from the wall, the toilet seat is too high, and missing a vertical grab bar. There is no accessible shower or changing room available.

63. WOMEN'S NON-ACCESSIBLE TOILET COMPARTMENTS

64. WOMEN'S ACCESSIBLE WATER CLOSET

65. WOMEN'S LAVATORIES

66. WOMEN'S GANG SHOWERS

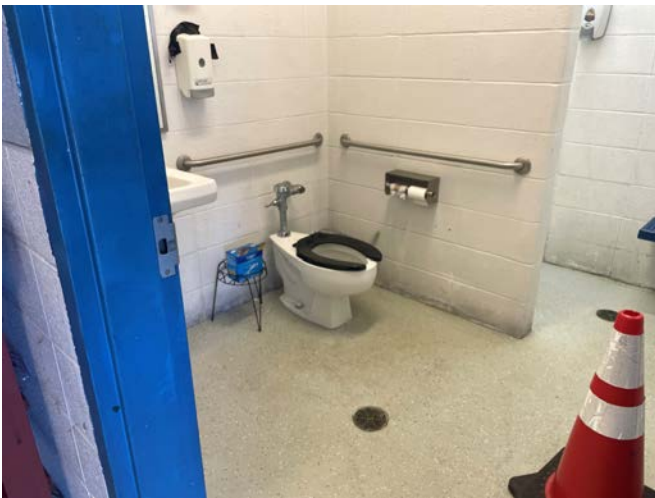
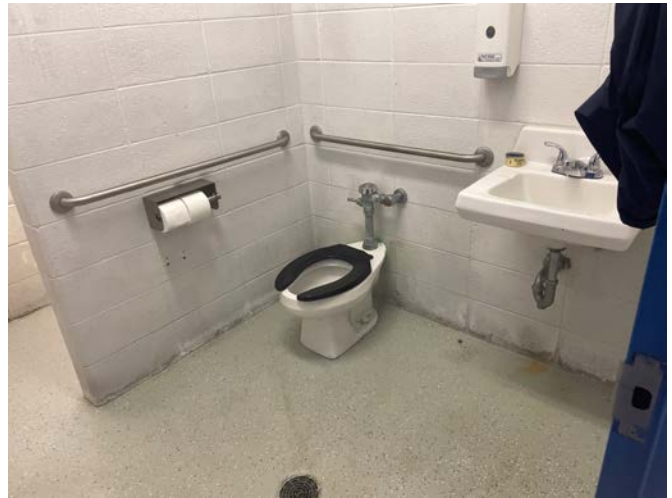
4. Both staff restrooms are not fully ADA compliant. The towel hooks are not within reach range. The toilet is not the correct distance from the wall and grab bars are not in the correct locations. The shower does not meet roll-in or transfer type shower requirements. Lavatories and mirrors are too high and there is exposed abrasive plumbing. See photos 67 and 68.

67. WOMEN'S STAFF RESTROOM

68. MEN'S STAFF RESTROOM
