COMMITTEE OF THE WHOLE AMENDED MEETING AGENDA  
TUESDAY OCTOBER 1, 2024, 7:00 PM  
BERLIN COMMON COUNCIL CHAMBERS  
Zoom Meeting ID: 893 1930 8907 Password: 123456

**Berlin Family Aquatic Center Pool Facility Evaluation**  
**ROUGH ORDER OF MAGNITUDE CONSTRUCTION ESTIMATE**  
**Monday, September 30, 2024**  
**Berlin Family Aquatic Center Pool Repairs and Improvements**  
**Ramaker & Associates Project #60575**

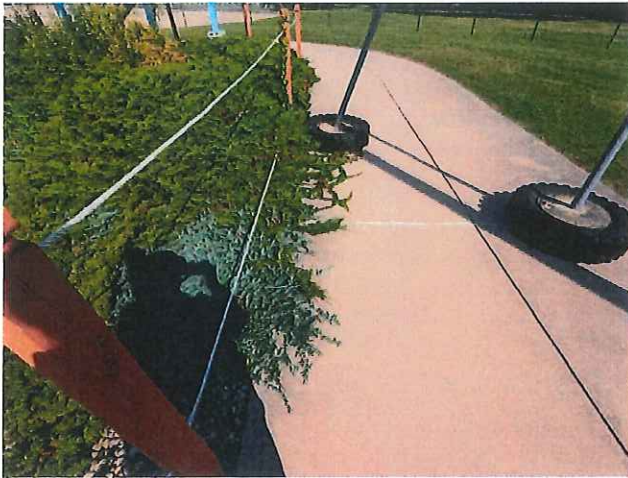
1. Pool Area Deck: Overall good condition, one crack noticed at the base of the diving board. There is landscaping that is growing onto the pool deck under the waterslide. This should be trimmed back to not cover the deck walkway. Continue maintenance as normal. See photo 03.

3. LANDSCAPING OVER THE POOL DECK

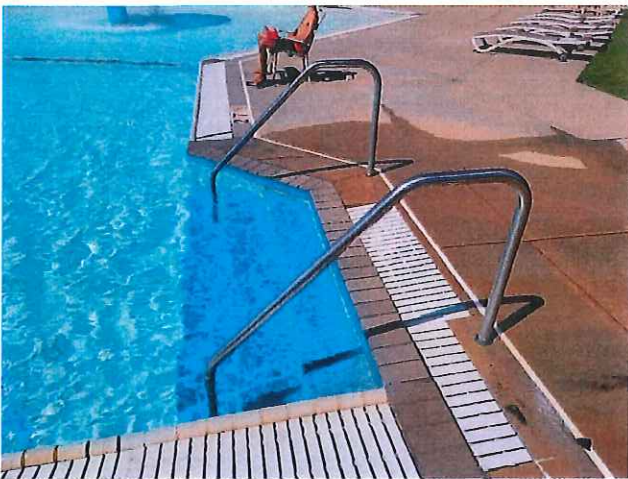
6. Pool Stairs: There is one set of stairs into the slide plunge area that appear to be in good condition. The handrails are 2'-9.5" tall and 5'-10.5" apart with minimal corrosion. Code requires that the leading edge of all steps be distinguished by a color contrasting with the color of the steps and pool floor. When the pool is refinished, this stripe should be added as well. Continue maintenance as required. See photos 05.

5. POOL STAIRS

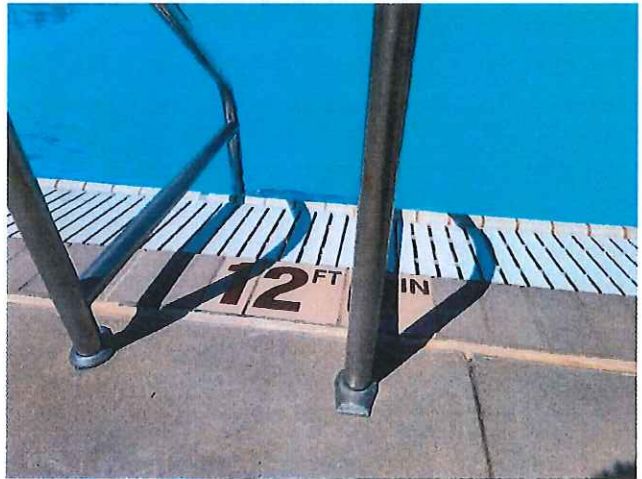
7. Pool Access Ladders: There are seven sets of access ladders, with one located in the middle of the diving hopper on the east end of the vessel. There is slight corrosion on the east dive hopper ladder and on the south shallow side ladder. See photos 06.

6. CORROSION ON POOL LADDER

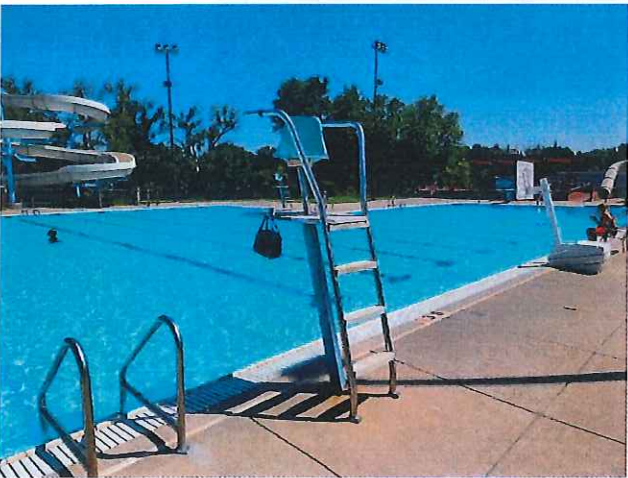
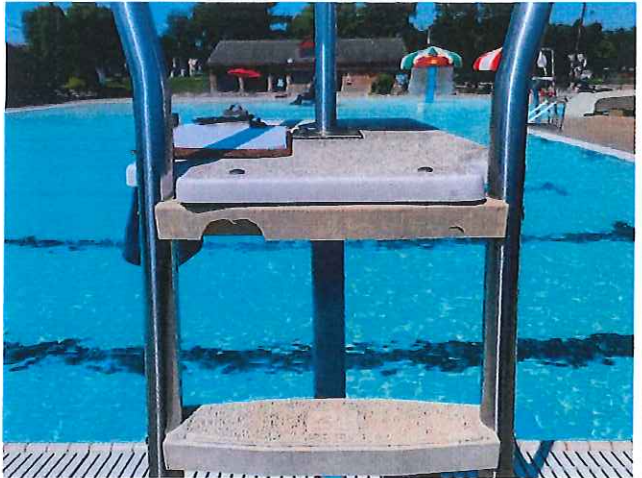
8. Lifeguard Chairs: There are four stationary chairs, and two portable chairs around the vessel. There was corrosion observed on all the lifeguard chairs to some degree, but they are otherwise in good condition. There is a broken support on the lifeguard chair on the east side of the lap lane area. The corrosion on each lifeguard chair should be treated as needed. Chairs that can't be repaired should be replaced to avoid failure in the future. See photos 07, and 08.

7. TYPICAL LIFEGUARD CHAIR

8. BROKEN SUPPORT ON LIFEGUARD CHAIR

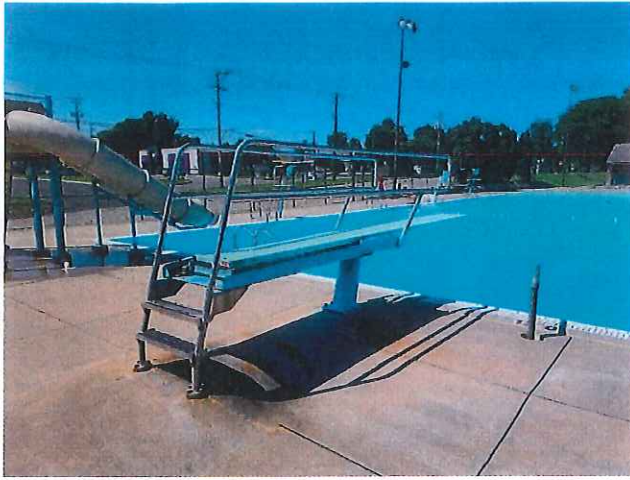
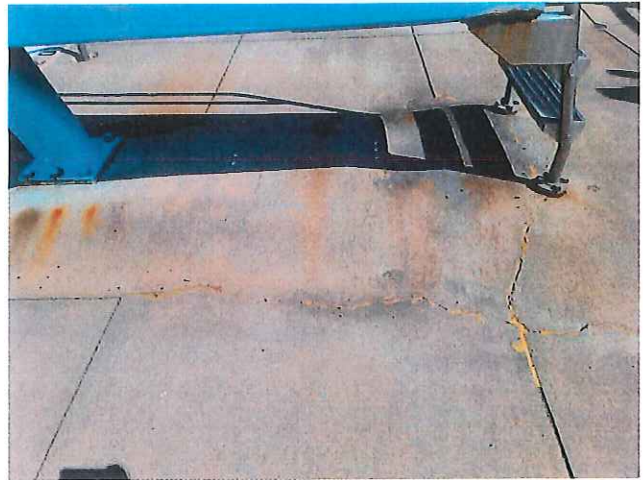
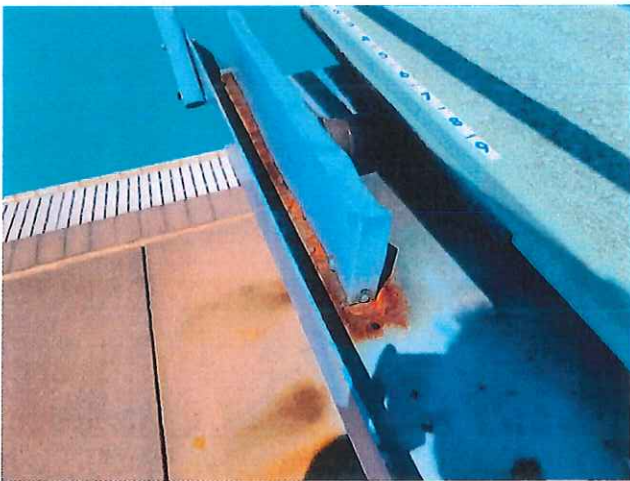
9. Diving Board: There is one 1-meter diving board into the dive hopper and there is significant corrosion present. This corrosion should be removed with a wire brush and refinished. Parts of the diving board that can't be repaired should be replaced to avoid failure in the future. A new diving board stand that is not like for like with the existing diving board, will require DSPS submittal. The decking around the diving board is cracked and should be monitored and maintained as needed. See photos 09, 10, and 11.

9. DIVING BOARD

10. CRACKING AROUND DIVING BOARD BASE

11. CORROSION ON DIVING BOARD ASSEMBLY

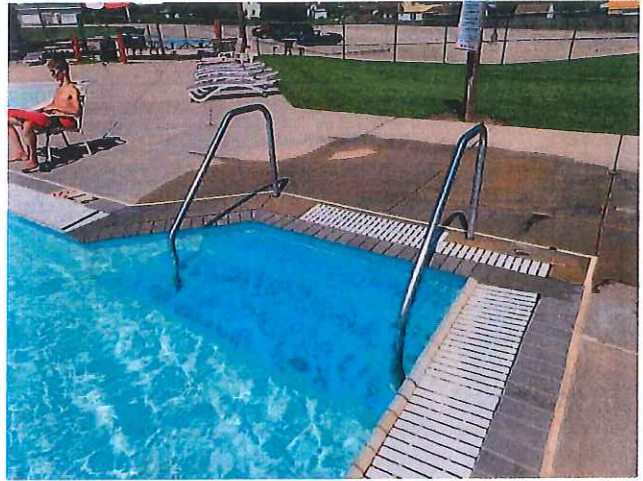
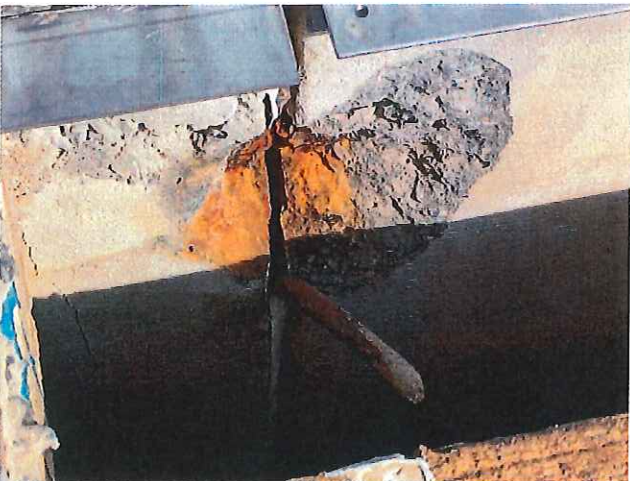
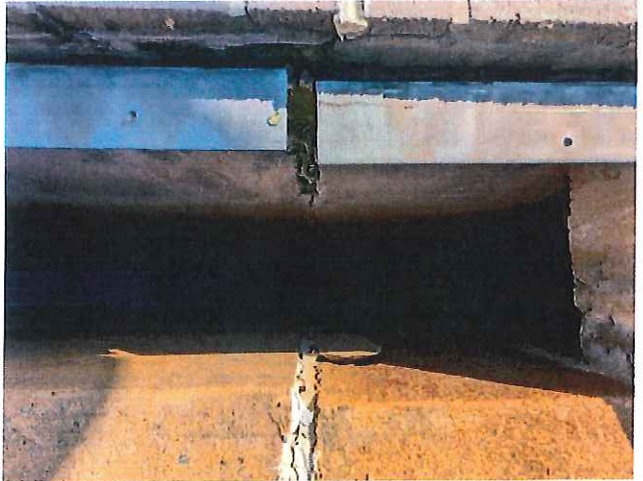
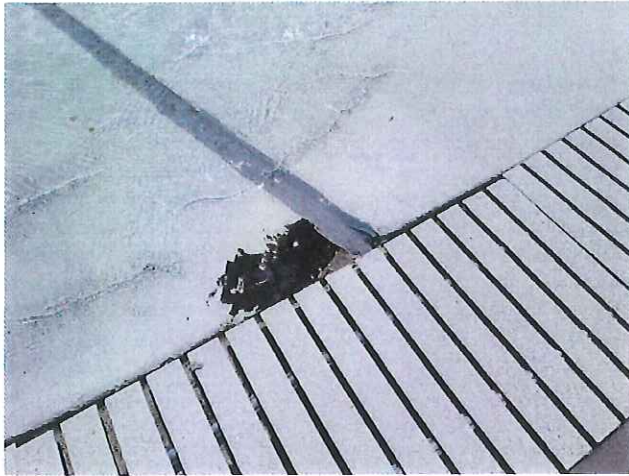
10. Slide Plunge Area: The slide plunge area shows signs of sinking with water running over the gutter by the stairs and onto the deck behind it. Further investigation is needed to determine the extent of the sinking in this corner. It is possible that the entire northern section of the pool from the zero-depth entry to the slide plunge has sunk. It appears that the northern section of the zero-depth entry is lower than the section adjacent to it. The nearby deck sections don't show any signs of cracking or strain. During the second site visit cracks in the gutter were observed on either side of the slide plunge area indicating settling. See photos 12, 13, 14 and 15.

12. WATER OVERFLOWING THE POOL STAIRS

13. BROKEN GUTTER JOINT

14. BROKEN GUTTER JOINT

15. NORTHERN SECTION APPEARS LOWER

- 1. Sunken Slide Plunge Area (approximately 600 square feet)
  - a. Ramaker recommends that a survey of the pool basin be completed to determine the bounds of the sunken portion of the pool vessel.

- b. From there, the sunken area should be demolished and replaced to make sure that the gutters and basin floor are in the correct position.
  - c. Ramaker also recommends ground penetrating radar (GPR) be performed to verify that there are no voids occurring under other parts of the pool basin.

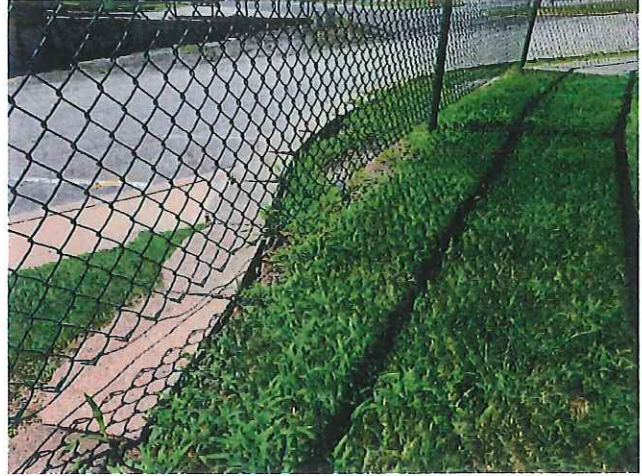
11. Pool Enclosure: The facility is surrounded by chain link fencing along the entire perimeter. There are gaps larger than 4" observed in several locations specifically on the southeast corner of the enclosure. The fencing should be repaired so that there are no gaps larger than 4" to meet pool code requirements. See photo 16. Update photo callout.

16. GAP UNDER FENCING LARGER THEN 4"

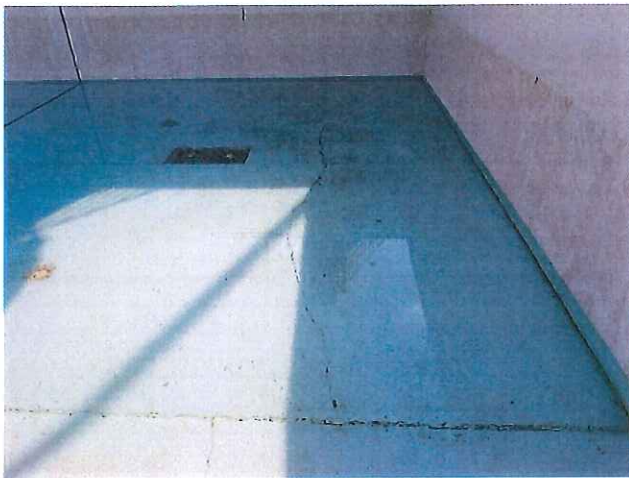
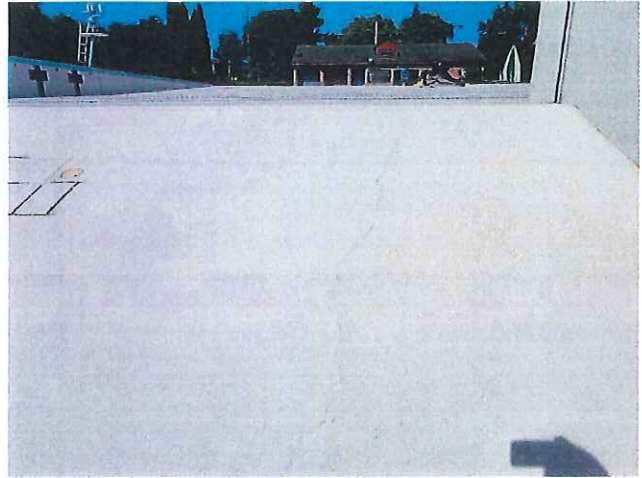
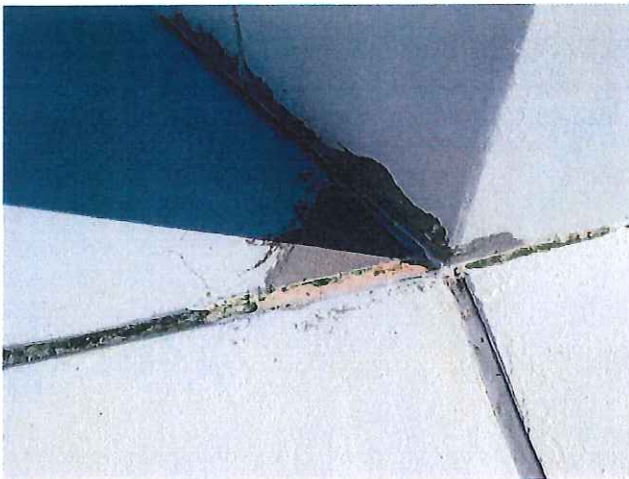
A significant effort has been put forth to keep this pool functional throughout the years. There are numerous surface cracks that were observed in the pool basin and the finish should be redone as it is flaking off in places around the pool vessel. See photos 17, 18, and 19.

17. CRACK IN DIVING HOPPER

18. CRACK ON TRANSITION PANEL

19. FINISH IS COMING OFF THE FLOOR

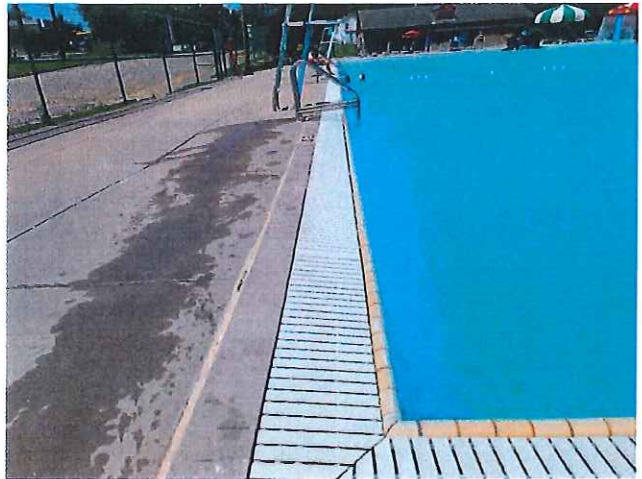
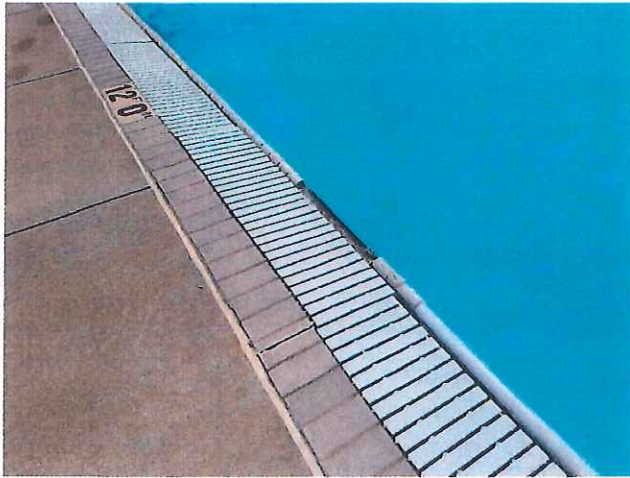
2. Pool Perimeter Overflow Gutter: The gutters physically looked to be in good condition except around the slide plunge area. As stated above, there were places on either side of the waterslide that were cracked. The bullnose piping that is used on the gutter rim is outdated and has been discontinued. There are areas where the bullnose has been broken and has been replaced with PVC pipe as a stopgap measure. Some tiles are missing altogether. Broken and missing tiles can result in sharp edges around the pool. Additionally, the operators reduced the water level in the pool to minimize water loss in the slide plunge area which led to improper rim flow over the majority of the pool perimeter. Ramaker recommends replacing the bullnose tile completely. See photos 20, and 21.

20. NO RIM FLOW OVER GUTTER

21. BROKEN GUTTER BULLNOSE

- a. The bullnose tile and waterline tile around the entire perimeter of the pool should be replaced as the current bullnose tile is obsolete and Berlin can't obtain anymore to help with repairs.

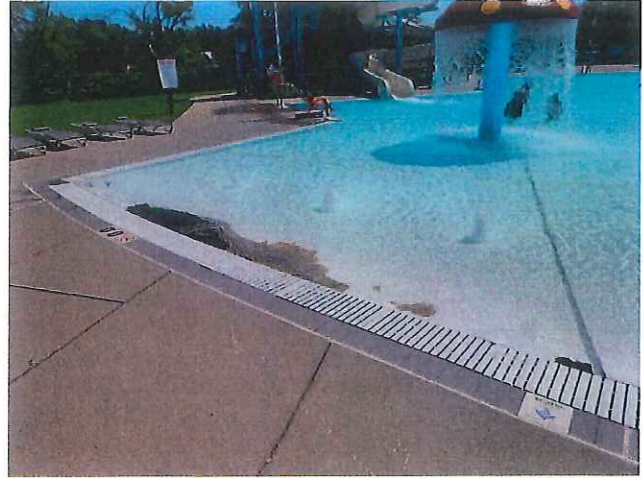
5. Basin Shell: Pool finish consists of painted concrete. The vessel was last painted 15 years ago and there are areas in the zero depth basin where the paint has flaked off exposing the concrete. Ramaker recommends repainting the areas as needed. See photo 22.

22. FINISH FLAKING OFF IN ZERO DEPTH AREA

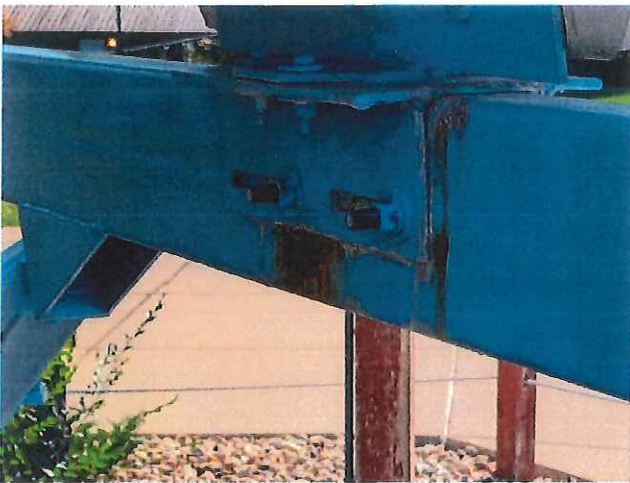
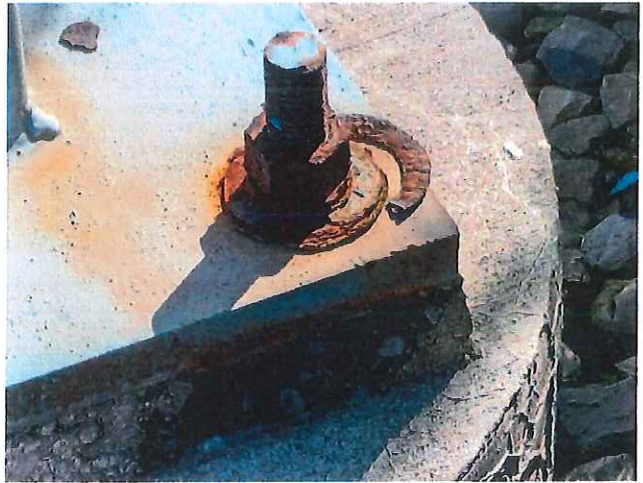
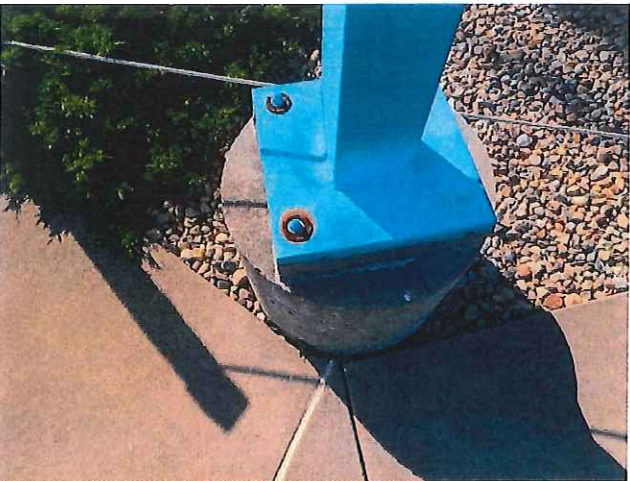
1. There are some spots of corrosion on the support structure that should be treated with a wire brush and have the finish reapplied. See photo 23.
2. There is corrosion present on some of the bolts on the structural as well. These bolts should be treated to remove the corrosion. Bolts that can't be treated should be replaced. See photo 24.
3. There are bolts outside the roped off area that don't have covers and could injure patrons passing by. All bolts within arm's reach should be covered to prevent this. See photo 25.

23. SUPPORT CORROSION

24. CORRODED BOLTS

25. EXPOSED FASTENERS OUTSIDE OF BARRIER

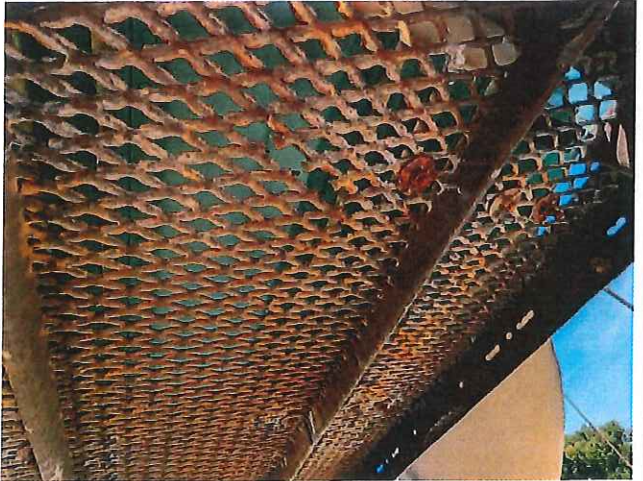
1. There is significant corrosion underneath the starting platform. This should be removed with a wire brush and then refinished. If this cannot be treated, the landing should be replaced. See photo 26.
2. Currently the stairs to the drop slide don't meet building code requirements and are grandfathered in. If the slide is removed, it will not be able to be reinstated with the current stairs.

26. CORROSION UNDER DROP SLIDE PLATFORM

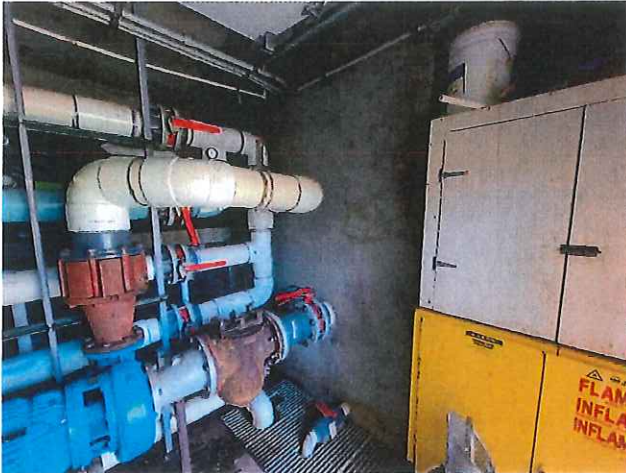
1. Overall, the surge tank appears to be in relatively good condition. No cracks in the tank walls, or leaks were noted. Continue maintenance as required.
2. The tank is supplied water from the pool perimeter gutter. The recirculation pump draws directly from the tank with no connections to the pool basin. See photo 27.

27. SURGE TANK IN MECHANICAL ROOM

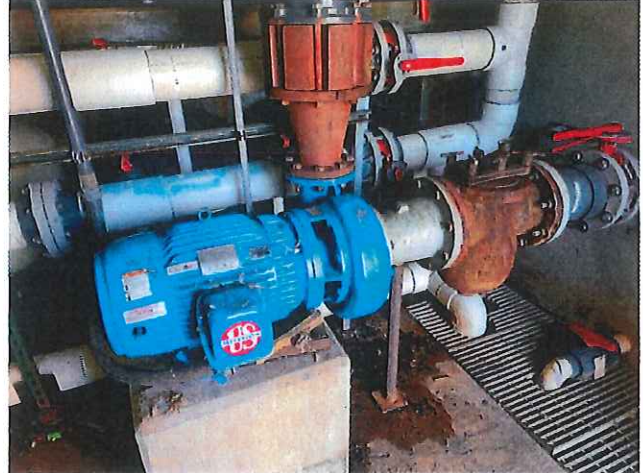
- *Recirculation Pump:* One 30 HP pump with some slight corrosion. Heavy corrosion on the reducers out of the pump and on the strainer. Aurora AS08-07144, 5X6X11, 341-BF, 1250 GPM @ 80 TDH, 1800 RPM. See photo 28.

28. CORROSION ON RECIRCULATION PUMP ASSEMBLY

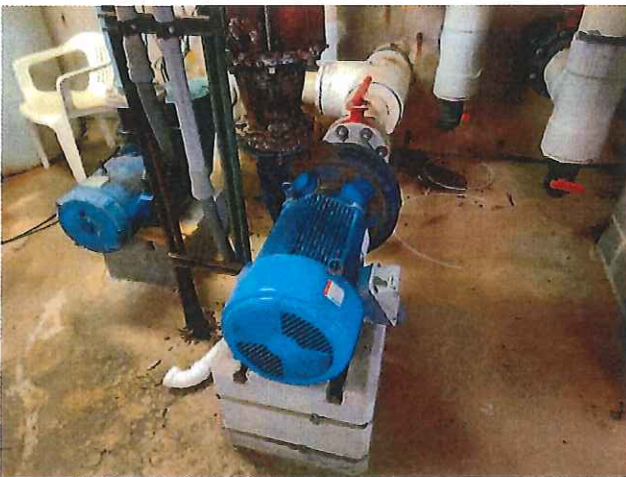
- *Waterslide Pump:* One 20 HP pump with some slight corrosion. Heavy corrosion on the reducers out of the pump and on the strainer. Aurora AS-09-12687, Model 5X6X11 - LB, 341-BF, 1000GPM @ 40 TDH, 1800 RPMs. See photo 29.

29. CORROSION ON WATERSLIDE PUMP ASSEMBLY

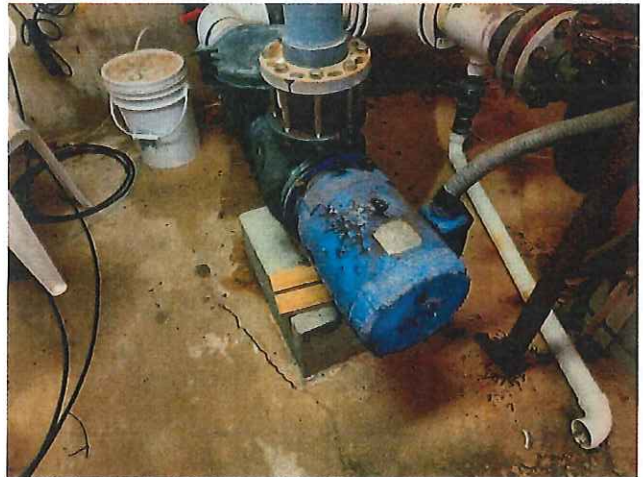
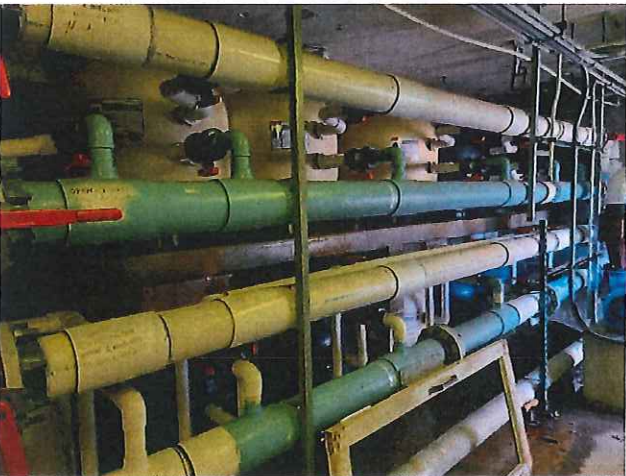
- *Water Feature Pump:* One 15 HP pump with some slight corrosion. Heavy corrosion on the reducers out of the pump. See photo 30.
- *Filter:* There are five Pentair Triton TR-140 filters and seven Astral Pool filters Model 27857 configured in a concrete shelf system with six on top and six on bottom. This configuration is likely not code compliant. The recirculation rate of the pool is 1250 GPM which requires 104.2 GPM per filter for equal flow. With the Astral filter areas at 6.84 square feet, they configuration can only supply 102.6 GPM maximum per the code required 15 GPM/square foot. The Astral filters should be replaced with Triton TR-140s to achieve balanced filtration. New, larger filters could be installed, but more of the equipment room would need to be redone to accommodate them. The filters appeared to be in good condition, however, some of the filters were leaking from their drain locations on bottom. See photo 31.

30. CORROSION ON FEATURE PUMP ASSEMBLY

31. FILTER ASSEMBLY

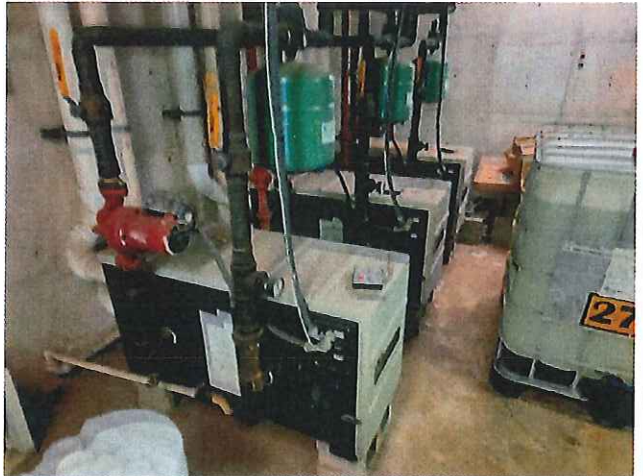
- *Pool Heat Exchangers:* There are three boilers that appear to be in good condition and are connected to two heat exchangers that is heating the pool. See photo 32.

32. THREE BOILERS

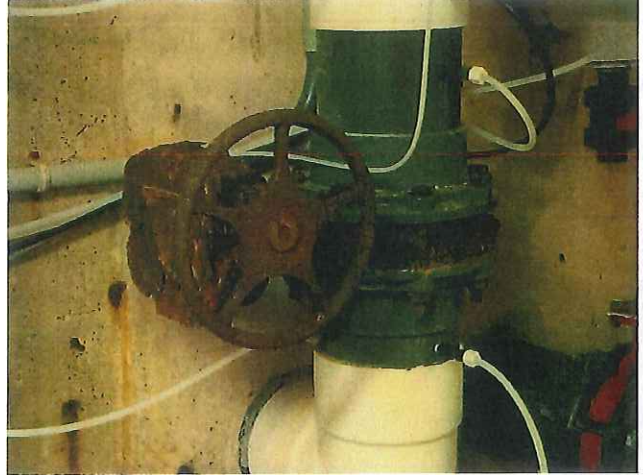
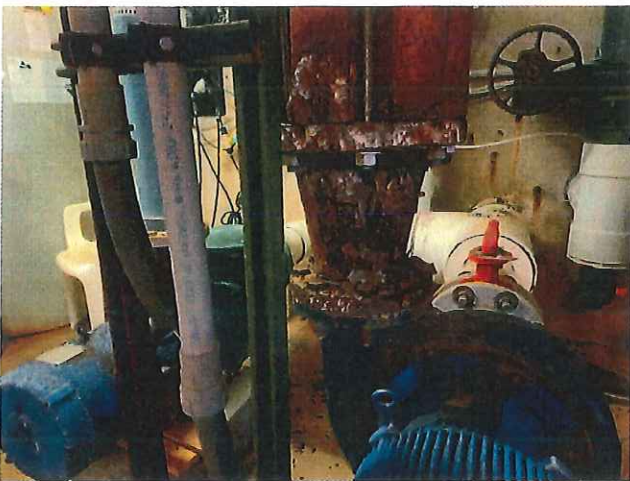
Visually there is severe corrosion present on all metal components in the mechanical room. The corrosion should be removed as necessary and equipment that can't be treated should be replaced as needed. See photos 34, and 35.

34. CORRODED VALVE

35. HEAVILY CORRODED REDUCER

- 3. Corroded Metal Components in the Mechanical Room
  - a. Ramaker recommends that all metal components showing signs of corrosion be replaced. This includes but is not limited to the following:

- i. Electrical boxes and panels.
    - ii. Water supply piping for the bathhouse.
    - iii. Metal piping out of the pumps.
    - iv. Pipe hangers.
- 4. Replacement of bullnose tile

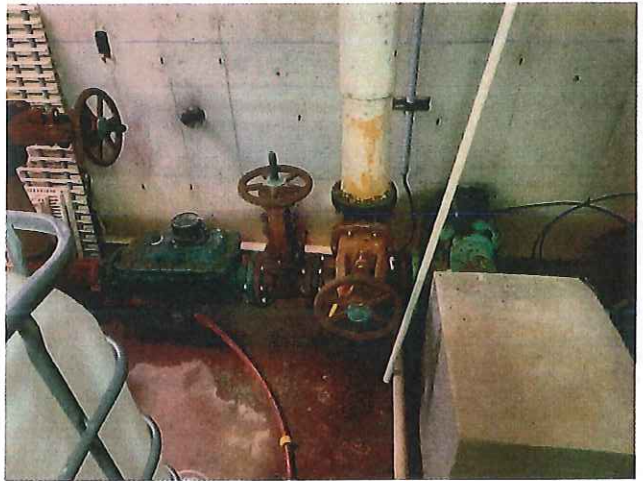
The supply water assembly train is located behind the chemical storage tanks in the mechanical space and is severely corroded. This should be replaced to prevent the system from failing. See photo 36.

36. CORRODED BATHHOUSE WATER TRAIN ASSEMBLY

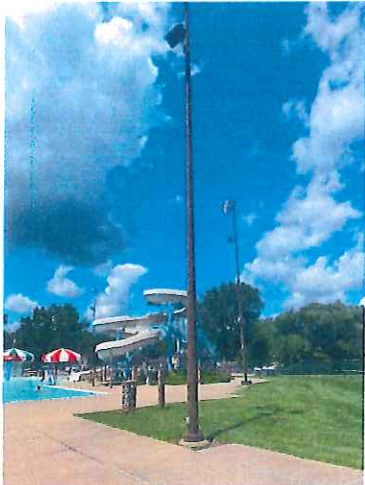
The pool facility has six light poles around the pool vessel that provide illumination for nighttime swimming. The light poles appear to be in good condition and Berlin staff desires to update the lighting to LED bulbs. For outdoor facilities according to DSPS code, the lighting shall provide a minimum of 3 footcandles of illumination at the water surface and on the decking. See photo 37.

37. POOL AREA LIGHT POLE

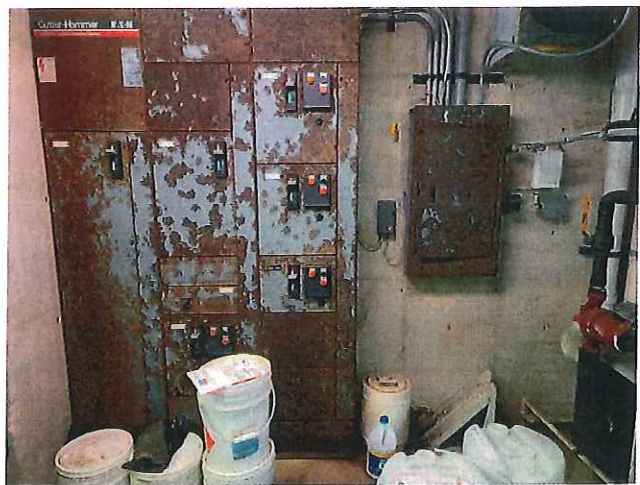
The entire electrical system for the pool facility is located in the pool equipment room below the pool deck. Due to proximity to the chemicals, there is severe corrosion present on the panels and boxes. See photo 38. No concerns were expressed to Ramaker by facility managers at the time of site visit. Continue to monitor and maintain electrical systems to ensure all equipment functions as needed when required.

38. CORRODED ELECTRICAL SYSTEM IN MECH ROOM

- 2. Chemical Rooms
  - a. Ramaker recommends installing two chemical rooms in the mechanical space to isolate the chemicals from the rest of the equipment and reduce the amount of corrosion.

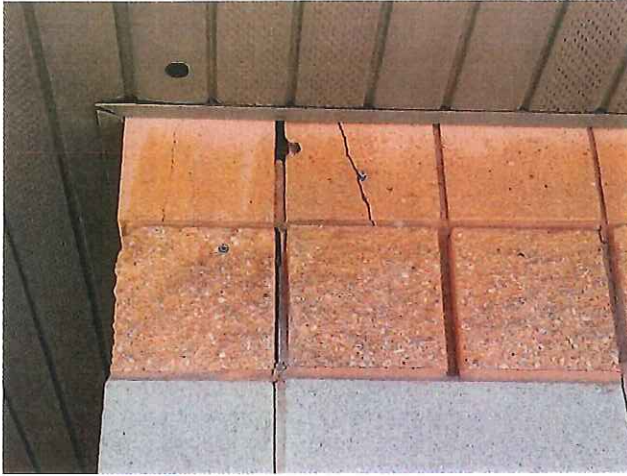
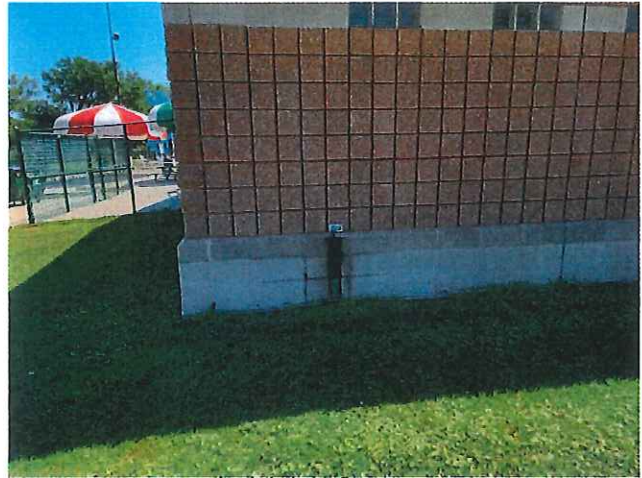
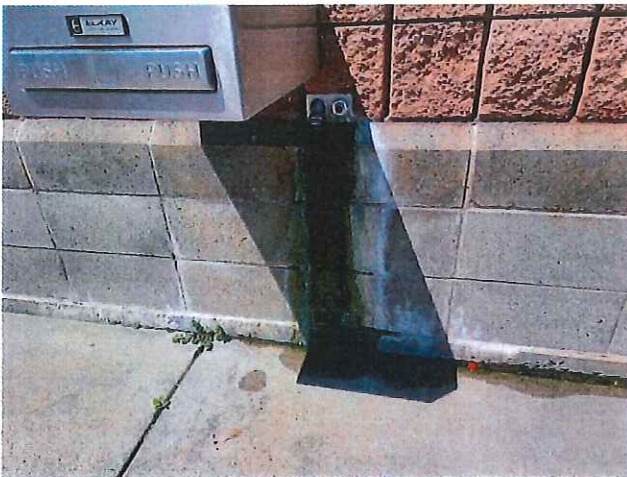
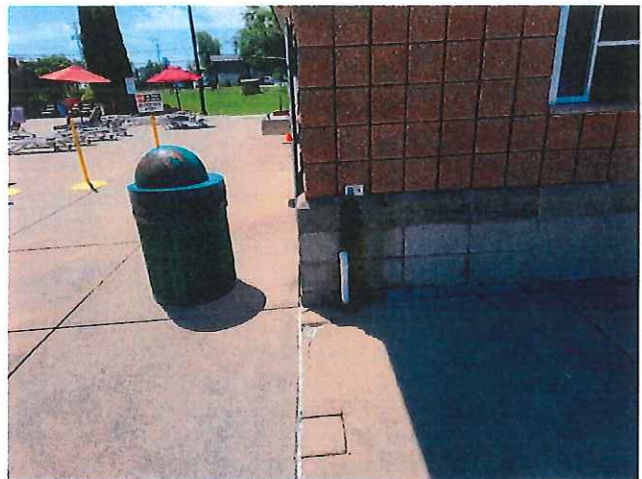
The Concrete Masonry Unit (CMU) walls of the building's exterior and interior are in good condition with no major structural deficiencies observed. There are a couple cracks at the exterior CMU with some separation at the mortar joints, see photo 39. There are instances of mineral deposits on the CMU below water bibs, see photos 40, 41, and 42.

39. CRACKS AND SEPARATION OF CMU

40. MINERAL DEPOSITS AT WATER BIB

41. MINERAL DEPOSITS AT WATER BIB

42. MINERAL DEPOSITS AT WATER BIB

- 6. Building Exterior
  - a. CMU cleaning at hose bibs.
  - b. Repointing CMU at cracks and replacing broken glass block.
  - c. Wood material will need typical wood maintenance, such as cleaning, replacing boards as needed, prepping for finish, and applying a finish.

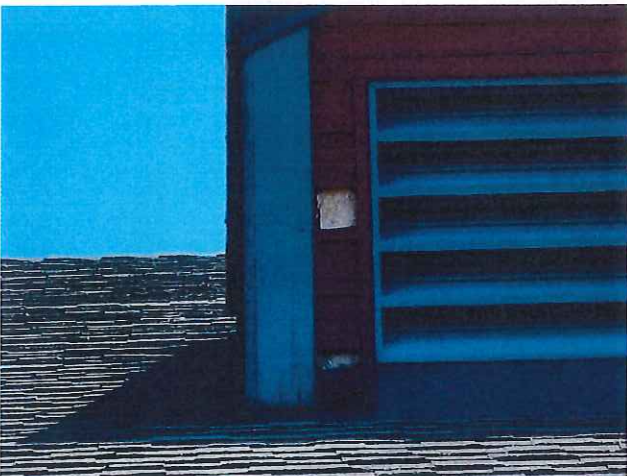
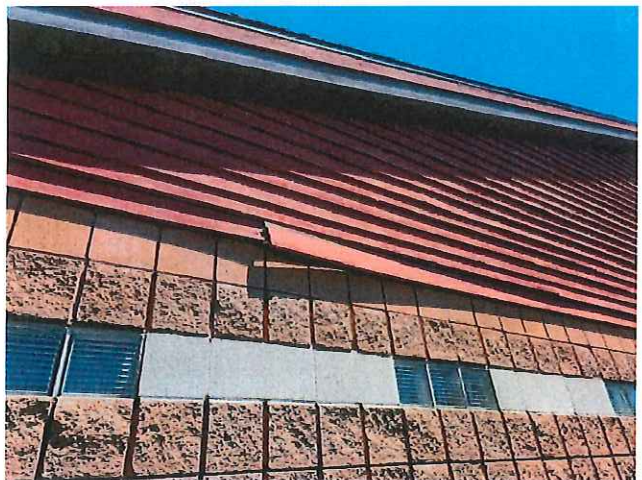
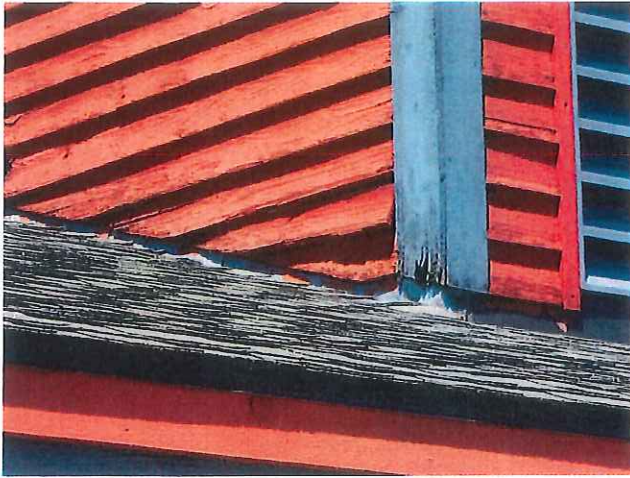
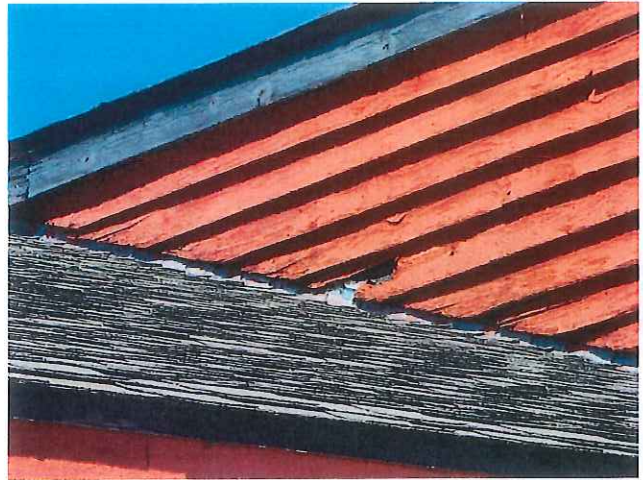
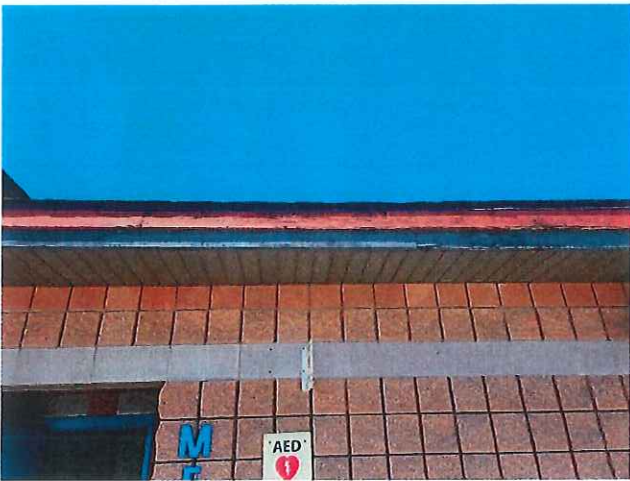
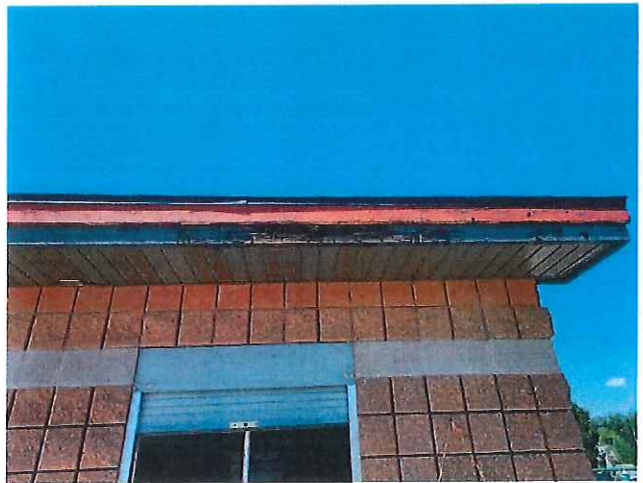
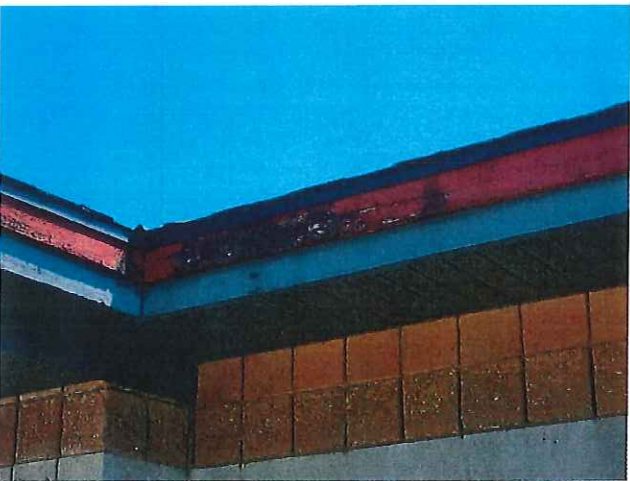
The wood siding above the CMU appears to be in fair condition with a couple instances where the siding is deteriorating and not attached correctly or missing, see photos 43, 44, 45, and 46. The wood fascia board has areas where the wood is also deteriorating, see photos 47, 48, and 49. The paint is peeling at the Men's and Women's poolside entrance soffit. Wood siding, wood fascia boards and wood soffits will need continued typical wood maintenance of cleaning, replacing boards as needed, prepping for finish, and applying a finish.

43. MISSING WOOD SIDING

44. WOOD SIDING NOT ATTACHED

45. WOOD SIDING DETERIORATING

46. WOOD SIDING DETERIORATING

47. WOOD FASCIA BOARD DETERIORATING

48. WOOD FASCIA BOARD DETERIORATING

49. WOOD FASCIA BOARD DETERIORATING

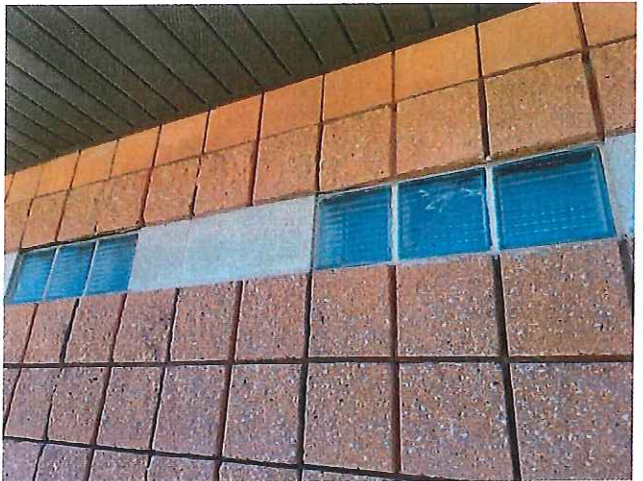
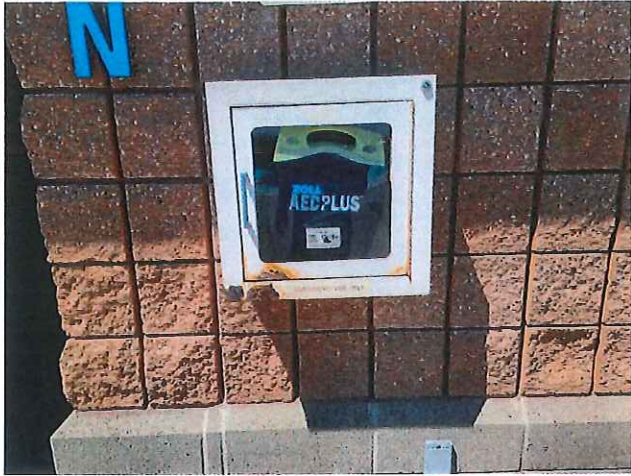
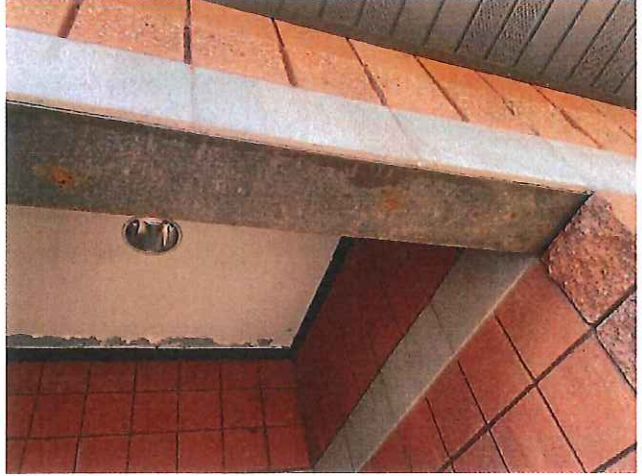
The exterior doors have some rust at the bottom of the doors and frames but otherwise seem to be in good condition. There are glass block windows in the exterior masonry wall with one broken glass block, see photo 50. The louvers throughout need cleaning. The AED cabinet is corroding along with a couple lintels, see photos 51 and 52.

50. BROKEN GLASS BLOCK

51. CORRODED AED CABINET

52. CORRODED LINTEL

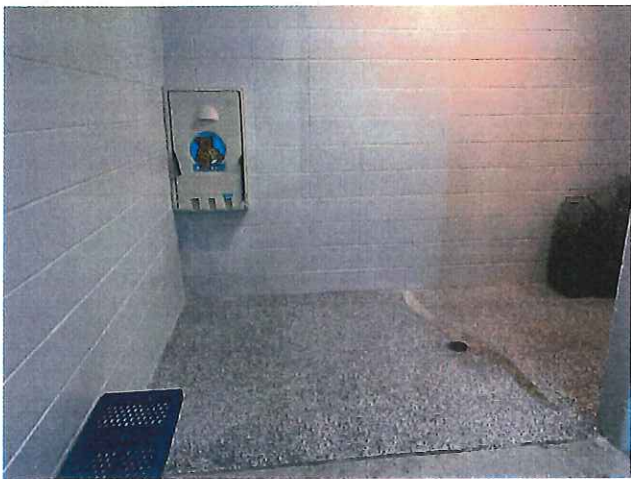
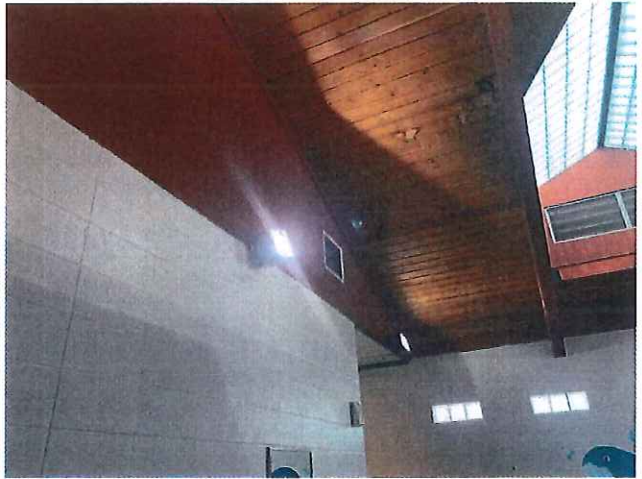
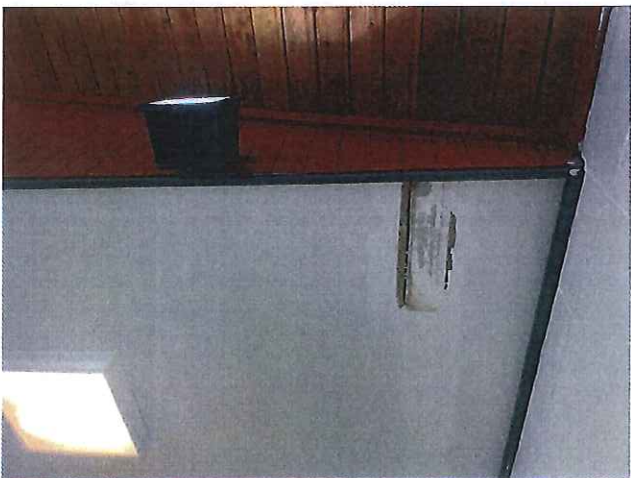
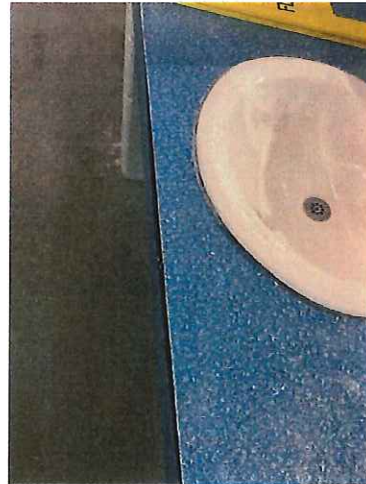
The floors throughout the bathhouse locker room and staff rooms are epoxy finished concrete, with signs of wear and tear. There is a significant crack observed at the women's poolside entrance, see photo 53. The CMU walls on the interior are painted and have mineral deposits and dirt built up throughout and towards the bottom. The wood wall finish above the CMU walls and wood ceiling boards are in good condition with some discoloration around the sky light. This may be an indication that there is or was water leaking, see photo 54. The painted ceilings in the Men's locker room show signs of damage and was repainted at some point, see photo 55. The countertop in the Women's locker room is delaminating, likely due to the presence of moisture, see photo 56.

53. CRACK IN FLOOR

54. DISCOLORATION AROUND SKY LIGHT

55. DAMAGED CEILING AT MEN'S LOCKER ROOM

56. DELAMINATING COUNTERTOP AT WOMEN'S LOCKER ROOM

- b. Damaged ceiling at the men's locker room should be repaired and further investigated to the cause of the damage.
- c. The countertop in the women's locker room should be relaminated or replaced.
- d. Door hinges at the mechanical room should be replaced with offset door hinges to gain the width of the door for removing equipment. If more room is desired the three doors and frames may need to be removed along with adjacent CMU wall as needed and replaced with three larger doors and frames.
- e. ADA-related items should be addressed as feasible. Minor items may be addressed as part of routine maintenance, whereas larger items may be addressed as a part of a larger renovation project. A Transition Plan should be established to document the intent to bring the facility into compliance as well as plan the best course of action.

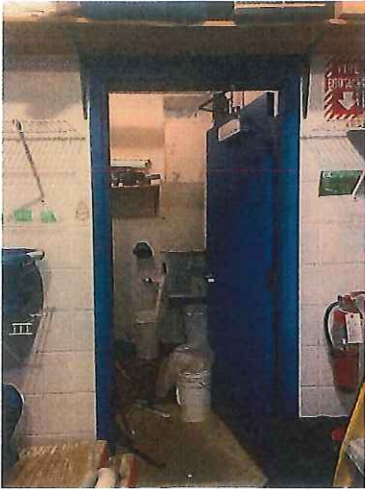
The equipment in the mechanical room is difficult to get in and out for winterization. There are three single flush doors for equipment to travel through, see photos 57 and 58. The door hinges could be replaced with offset door hinges to increase the width of the door.

57. MECHANICAL ROOM DOOR
