**CITY OF BERLIN
COMMON COUNCIL MEETING
STAFF REPORT**

TO: Common Council
FROM: Planning and Development Director
RE: 208 Broadway. TID Building Improvement Program Application
DATE: April 8th 2025

This report provides a summary of noted concerns and potential improvements for consideration by the City of Berlin. Photographs can be found in **Appendix A** for reference. Initial photos 01 and 02 provide an overall view of the facility and bathhouse.

Berlin Family Aquatic Center Pool Repairs and Improvements
Ramaker & Associates Project #60575

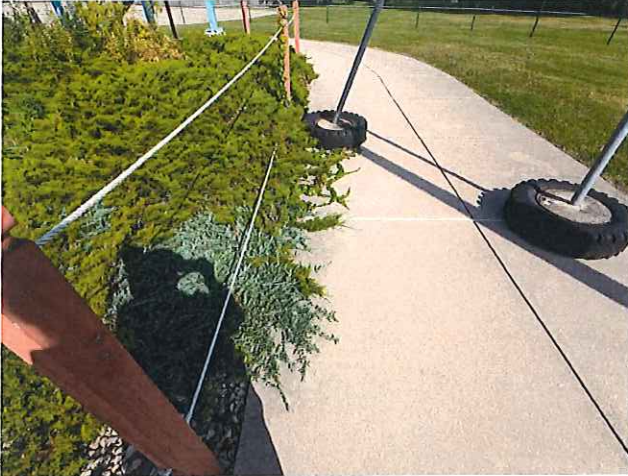
1. Pool Area Deck: Overall good condition, one crack noticed at the base of the diving board. There is landscaping that is growing onto the pool deck under the waterslide. This should be trimmed back to not cover the deck walkway. Continue maintenance as normal. See photo 03.

3. LANDSCAPING OVER THE POOL DECK

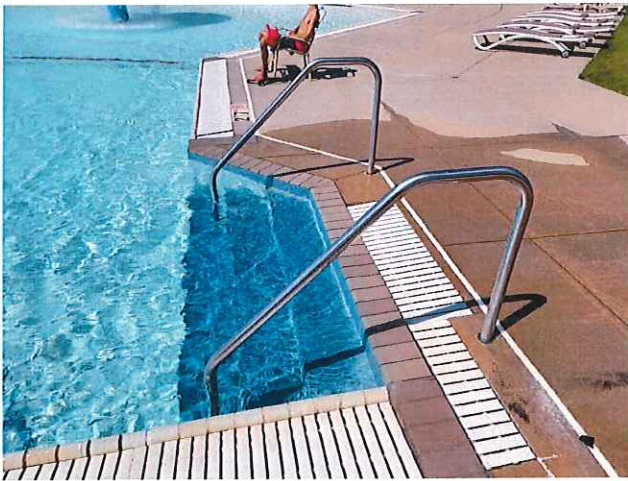
6. Pool Stairs: There is one set of stairs into the slide plunge area that appear to be in good condition. The handrails are 2'-9.5" tall and 5'-10.5" apart with minimal corrosion. Code requires that the leading edge of all steps be distinguished by a color contrasting with the color of the steps and pool floor. When the pool is refinished, this stripe should be added as well. Continue maintenance as required. See photos 05.

5. POOL STAIRS

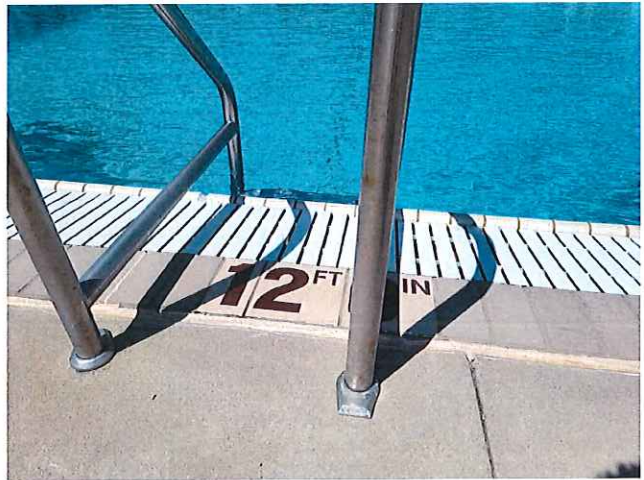
7. Pool Access Ladders: There are seven sets of access ladders, with one located in the middle of the diving hopper on the east end of the vessel. There is slight corrosion on the east dive hopper ladder and on the south shallow side ladder. See photos 06.

6. CORROSION ON POOL LADDER

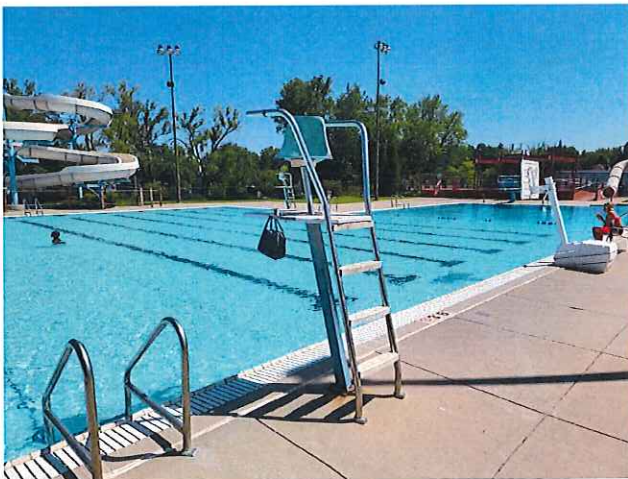
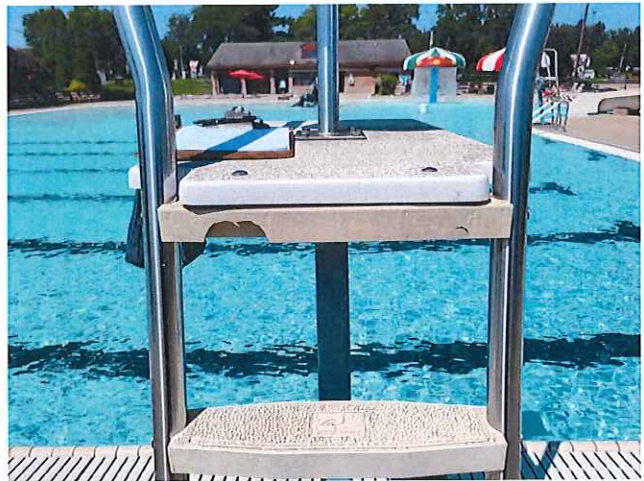
8. Lifeguard Chairs: There are four stationary chairs, and two portable chairs around the vessel. There was corrosion observed on all the lifeguard chairs to some degree, but they are otherwise in good condition. There is a broken support on the lifeguard chair on the east side of the lap lane area. The corrosion on each lifeguard chair should be treated as needed. Chairs that can't be repaired should be replaced to avoid failure in the future. See photos 07, and 08.

7. TYPICAL LIFEGUARD CHAIR

8. BROKEN SUPPORT ON LIFEGUARD CHAIR

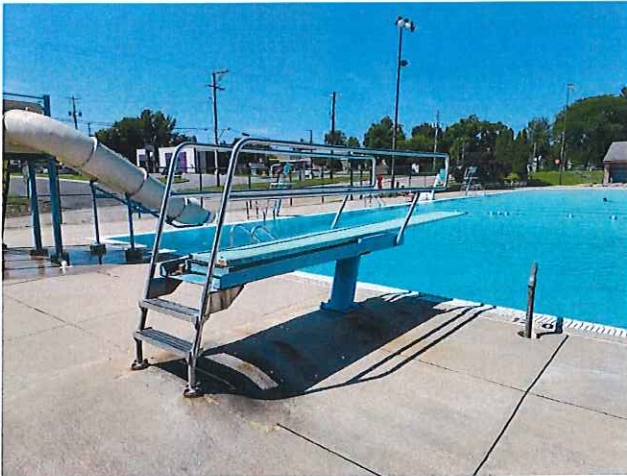
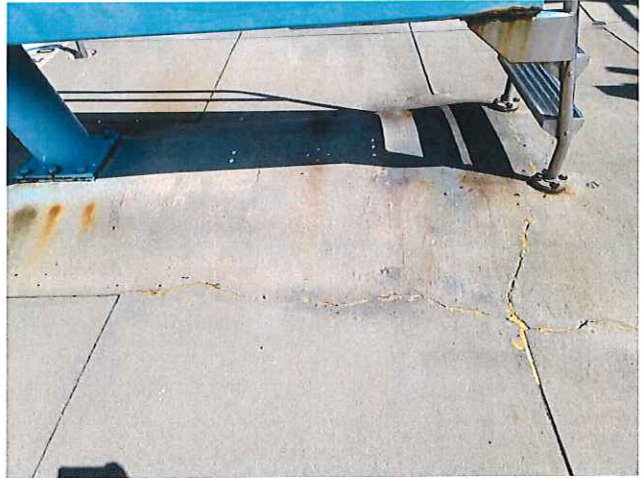
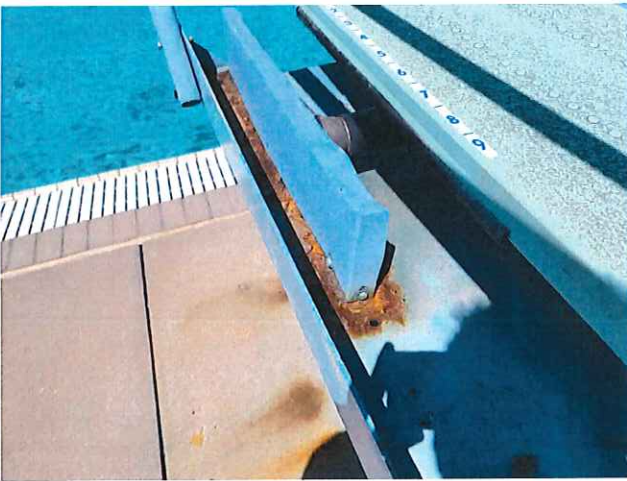
9. Diving Board: There is one 1-meter diving board into the dive hopper and there is significant corrosion present. This corrosion should be removed with a wire brush and refinished. Parts of the diving board that can't be repaired should be replaced to avoid failure in the future. A new diving board stand that is not like for like with the existing diving board, will require DSPS submittal. The decking around the diving board is cracked and should be monitored and maintained as needed. See photos 09, 10, and 11.

9. DIVING BOARD

10. CRACKING AROUND DIVING BOARD BASE

11. CORROSION ON DIVING BOARD ASSEMBLY

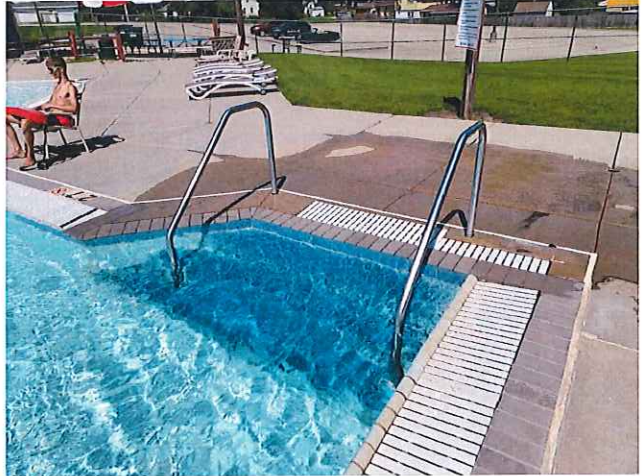
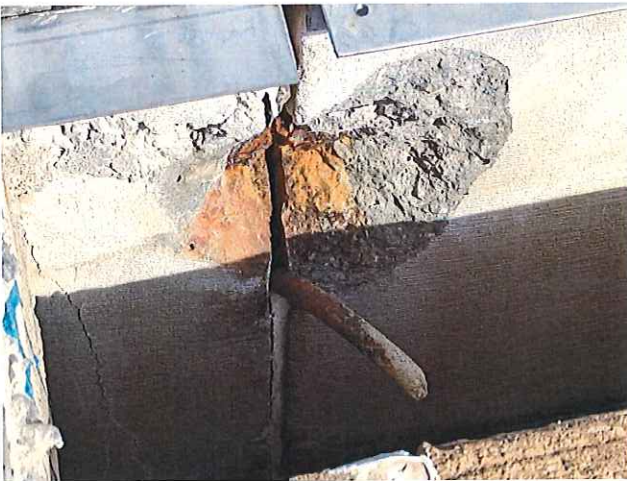
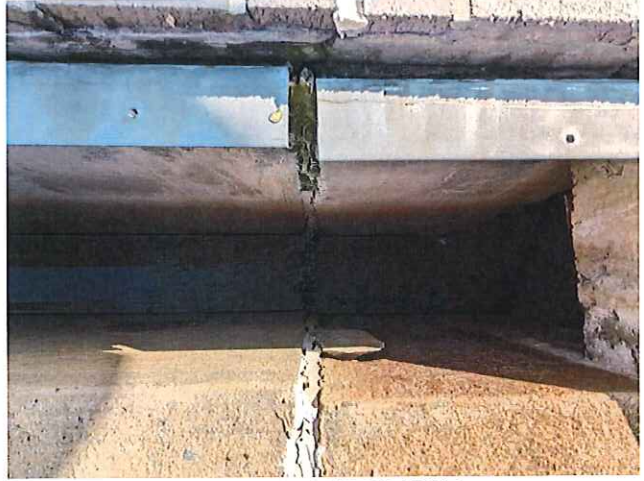
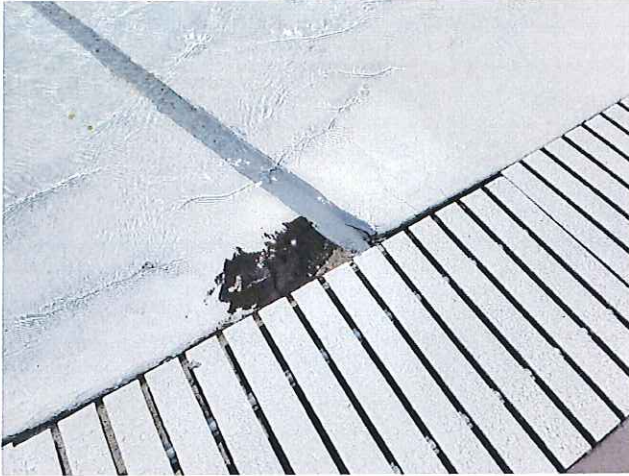
- Slide Plunge Area – Starting approximately 10-12 years ago, Berlin noticed that they were losing water over the edge of the pool by the stairs into the slide plunge area. Berlin expressed that the water loss has increased in the past five years. During the visit it was clear to Ramaker that some sinking had occurred in that corner of the vessel. During the second visit Ramaker observed large cracks in the gutter on either side of the slide plunge area indicating that this area has settled. It appears that the slide plunge area is the only part that is sunk. However, before repairs are made, a survey of the empty vessel will need to be conducted to accurately determine the bounds of reconstruction. To reduce water loss during use, the operators of the facility lowered the water level in the vessel during the time of the visit. Ramaker was unable to determine if other areas of the pool were impacted due to inconsistent rim flow over the gutter around the pool perimeter.

10. Slide Plunge Area: The slide plunge area shows signs of sinking with water running over the gutter by the stairs and onto the deck behind it. Further investigation is needed to determine the extent of the sinking in this corner. It is possible that the entire northern section of the pool from the zero-depth entry to the slide plunge has sunk. It appears that the northern section of the zero-depth entry is lower than the section adjacent to it. The nearby deck sections don't show any signs of cracking or strain. During the second site visit cracks in the gutter were observed on either side of the slide plunge area indicating settling. See photos 12, 13, 14 and 15.

12. WATER OVERFLOWING THE POOL STAIRS

13. BROKEN GUTTER JOINT

14. BROKEN GUTTER JOINT

15. NORTHERN SECTION APPEARS LOWER

1. Sunken Slide Plunge Area (approximately 600 square feet)
 - a. Ramaker recommends that a survey of the pool basin be completed to determine the bounds of the sunken portion of the pool vessel.

- b. From there, the sunken area should be demolished and replaced to make sure that the gutters and basin floor are in the correct position.
 - c. Ramaker also recommends ground penetrating radar (GPR) be performed to verify that there are no voids occurring under other parts of the pool basin.

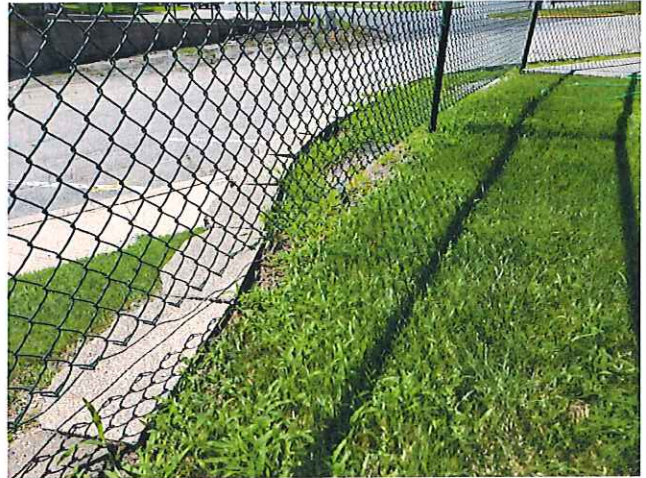
11. Pool Enclosure: The facility is surrounded by chain link fencing along the entire perimeter. There are gaps larger than 4" observed in several locations specifically on the southeast corner of the enclosure. The fencing should be repaired so that there are no gaps larger than 4" to meet pool code requirements. See photo 16. Update photo callout.

16. GAP UNDER FENCING LARGER THEN 4"

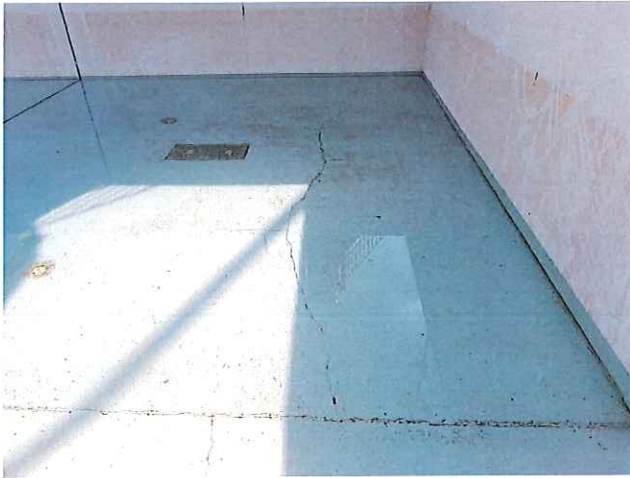
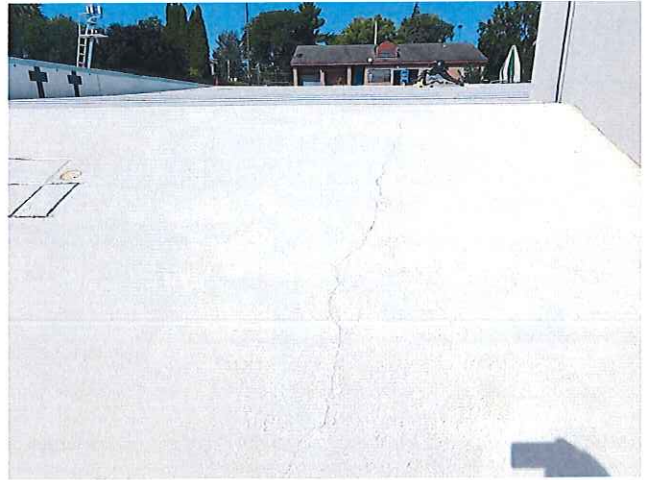
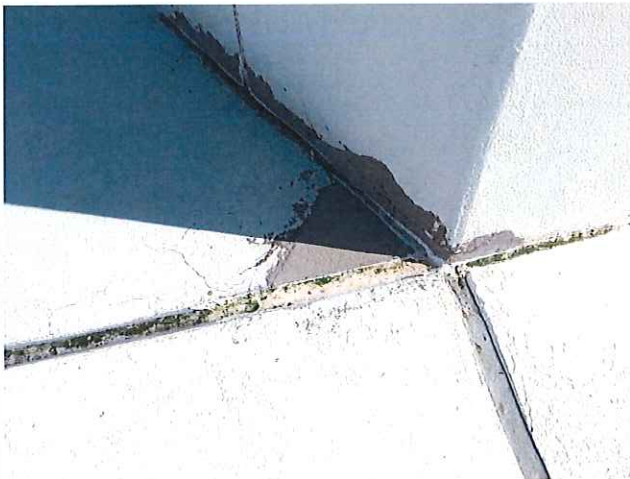
A significant effort has been put forth to keep this pool functional throughout the years. There are numerous surface cracks that were observed in the pool basin and the finish should be redone as it is flaking off in places around the pool vessel. See photos 17, 18, and 19.

17. CRACK IN DIVING HOPPER

18. CRACK ON TRANSITION PANEL

19. FINISH IS COMING OFF THE FLOOR

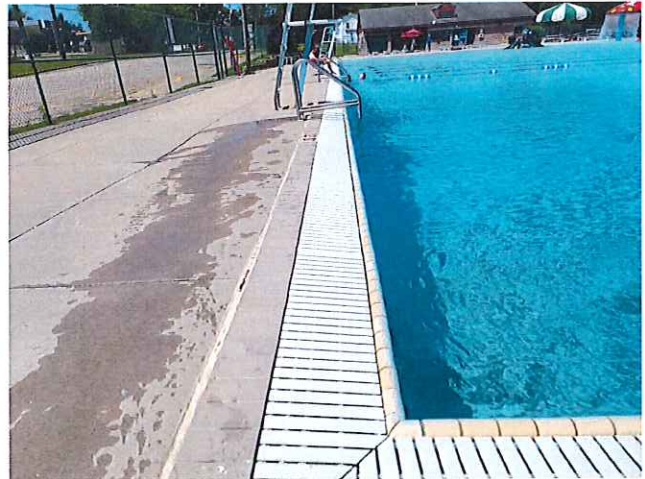
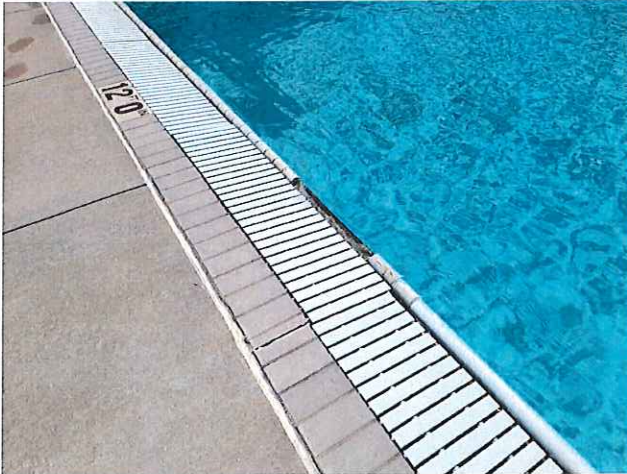
2. Pool Perimeter Overflow Gutter: The gutters physically looked to be in good condition except around the slide plunge area. As stated above, there were places on either side of the waterslide that were cracked. The bullnose piping that is used on the gutter rim is outdated and has been discontinued. There are areas where the bullnose has been broken and has been replaced with PVC pipe as a stopgap measure. Some tiles are missing altogether. Broken and missing tiles can result in sharp edges around the pool. Additionally, the operators reduced the water level in the pool to minimize water loss in the slide plunge area which led to improper rim flow over the majority of the pool perimeter. Ramaker recommends replacing the bullnose tile completely. See photos 20, and 21.

20. NO RIM FLOW OVER GUTTER

21. BROKEN GUTTER BULLNOSE

- a. The bullnose tile and waterline tile around the entire perimeter of the pool should be replaced as the current bullnose tile is obsolete and Berlin can't obtain anymore to help with repairs.

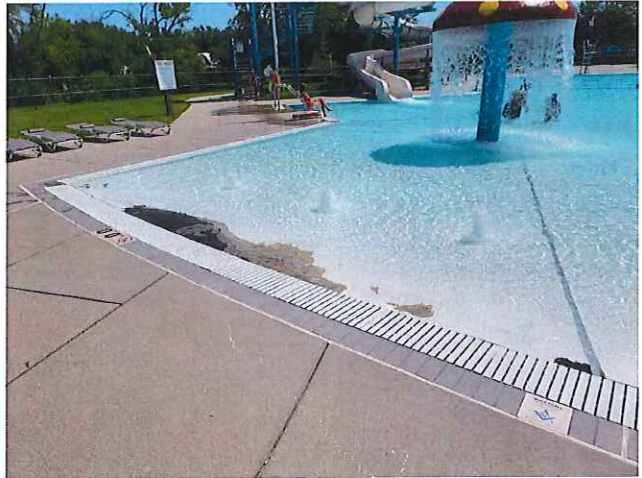
5. Basin Shell: Pool finish consists of painted concrete. The vessel was last painted 15 years ago and there are areas in the zero depth basin where the paint has flaked off exposing the concrete. Ramaker recommends repainting the areas as needed. See photo 22.

22. FINISH FLAKING OFF IN ZERO DEPTH AREA

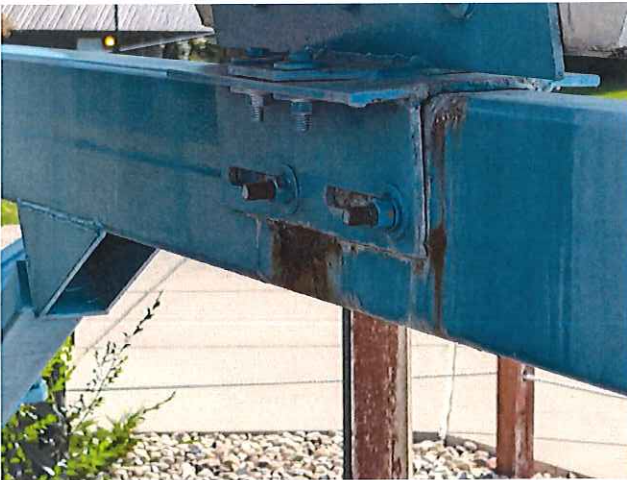
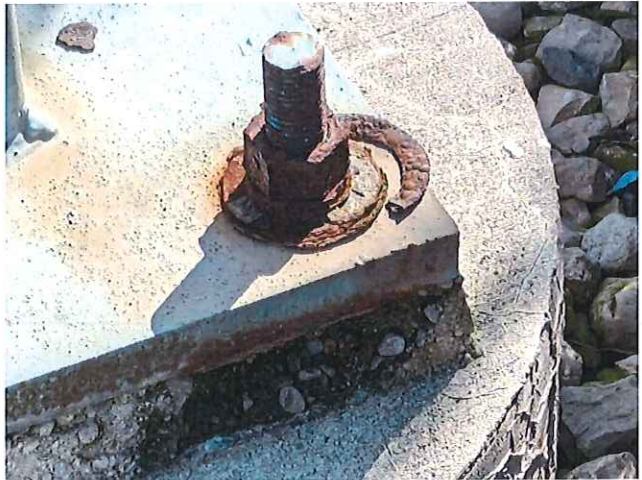
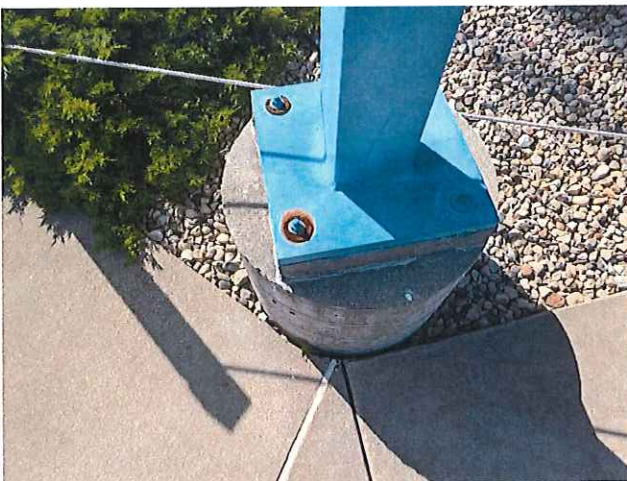
1. There are some spots of corrosion on the support structure that should be treated with a wire brush and have the finish reapplied. See photo 23.
2. There is corrosion present on some of the bolts on the structural as well. These bolts should be treated to remove the corrosion. Bolts that can't be treated should be replaced. See photo 24.
3. There are bolts outside the roped off area that don't have covers and could injure patrons passing by. All bolts within arm's reach should be covered to prevent this. See photo 25.

23. SUPPORT CORROSION

24. CORRODED BOLTS

25. EXPOSED FASTENERS OUTSIDE OF BARRIER

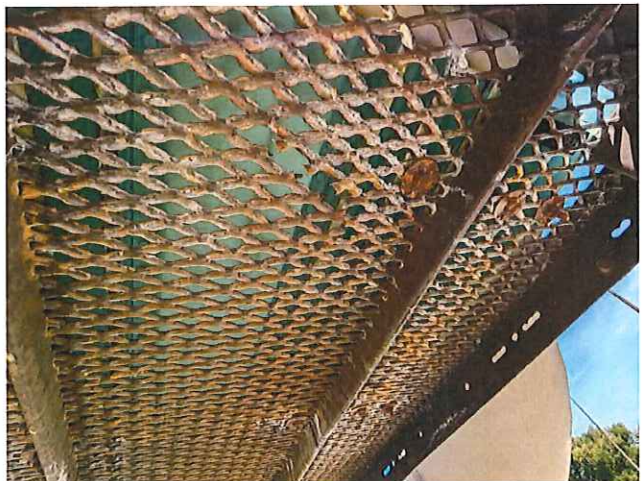
1. There is significant corrosion underneath the starting platform. This should be removed with a wire brush and then refinished. If this cannot be treated, the landing should be replaced. See photo 26.
2. Currently the stairs to the drop slide don't meet building code requirements and are grandfathered in. If the slide is removed, it will not be able to be reinstalled with the current stairs.

26. CORROSION UNDER DROP SLIDE PLATFORM

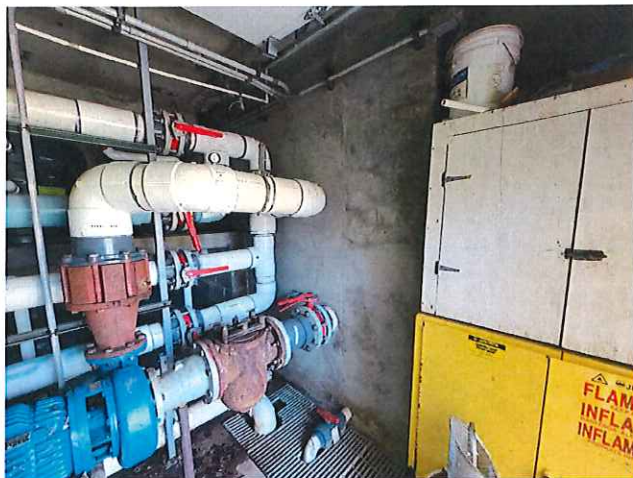
1. Overall, the surge tank appears to be in relatively good condition. No cracks in the tank walls, or leaks were noted. Continue maintenance as required.
2. The tank is supplied water from the pool perimeter gutter. The recirculation pump draws directly from the tank with no connections to the pool basin. See photo 27.

27. SURGE TANK IN MECHANICAL ROOM

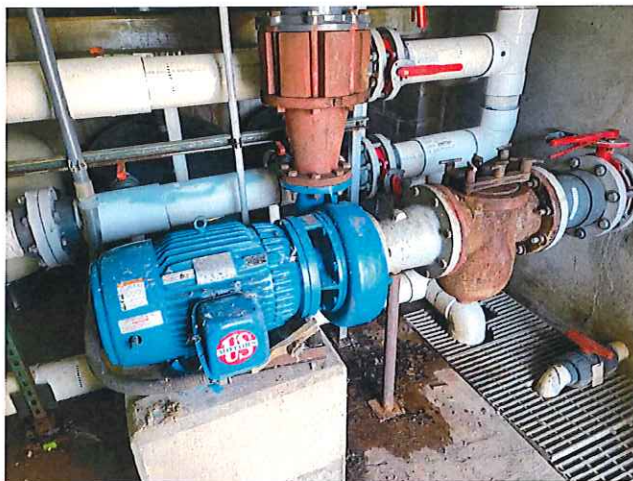
- *Recirculation Pump:* One 30 HP pump with some slight corrosion. Heavy corrosion on the reducers out of the pump and on the strainer. Aurora AS08-07144, 5X6X11, 341-BF, 1250 GPM @ 80 TDH, 1800 RPM. See photo 28.

28. CORROSION ON RECIRCULATION PUMP ASSEMBLY

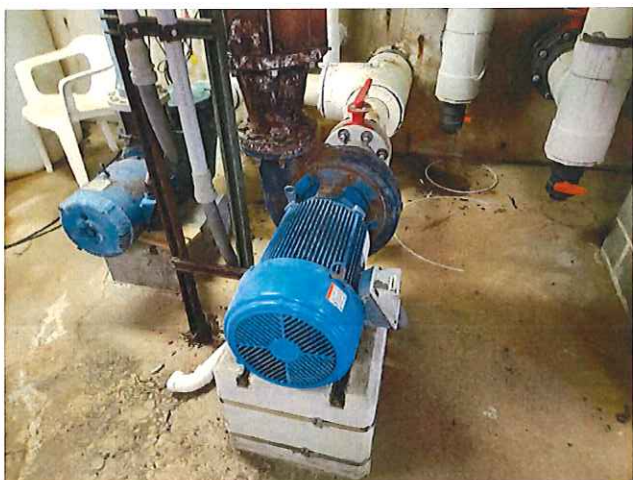
- *Waterslide Pump:* One 20 HP pump with some slight corrosion. Heavy corrosion on the reducers out of the pump and on the strainer. Aurora AS-09-12687, Model 5X6X11 – LB, 341-BF, 1000GPM @ 40 TDH, 1800 RPMs. See photo 29.

29. CORROSION ON WATERSLIDE PUMP ASSEMBLY

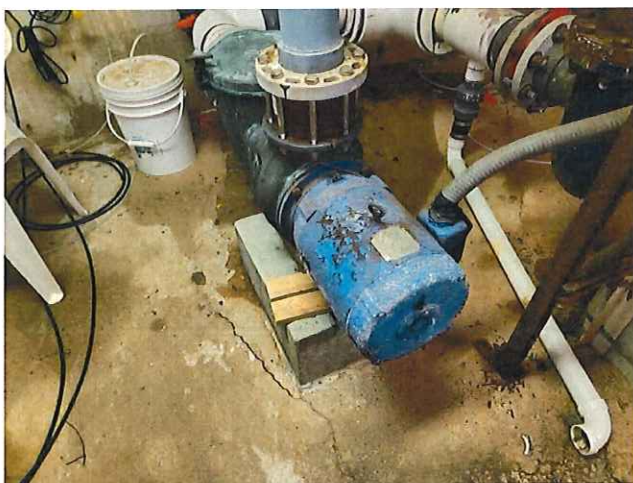
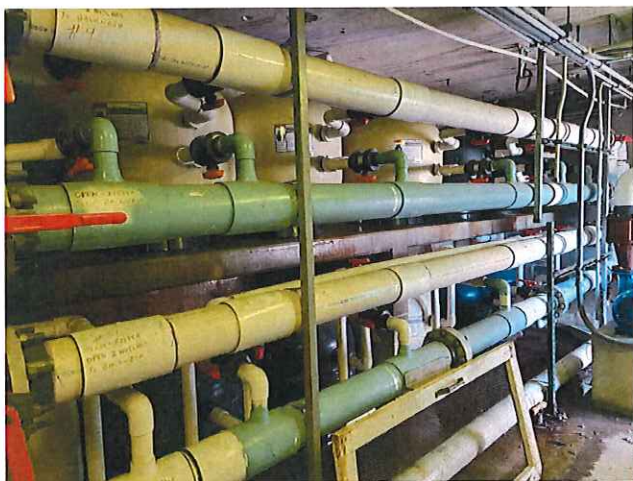
- *Water Feature Pump:* One 15 HP pump with some slight corrosion. Heavy corrosion on the reducers out of the pump. See photo 30.
- *Filter:* There are five Pentair Triton TR-140 filters and seven Astral Pool filters Model 27857 configured in a concrete shelf system with six on top and six on bottom. This configuration is likely not code compliant. The recirculation rate of the pool is 1250 GPM which requires 104.2 GPM per filter for equal flow. With the Astral filter areas at 6.84 square feet, they configuration can only supply 102.6 GPM maximum per the code required 15 GPM/square foot. The Astral filters should be replaced with Triton TR-140s to achieve balanced filtration. New, larger filters could be installed, but more of the equipment room would need to be redone to accommodate them. The filters appeared to be in good condition, however, some of the filters were leaking from their drain locations on bottom. See photo 31.

30. CORROSION ON FEATURE PUMP ASSEMBLY

31. FILTER ASSEMBLY

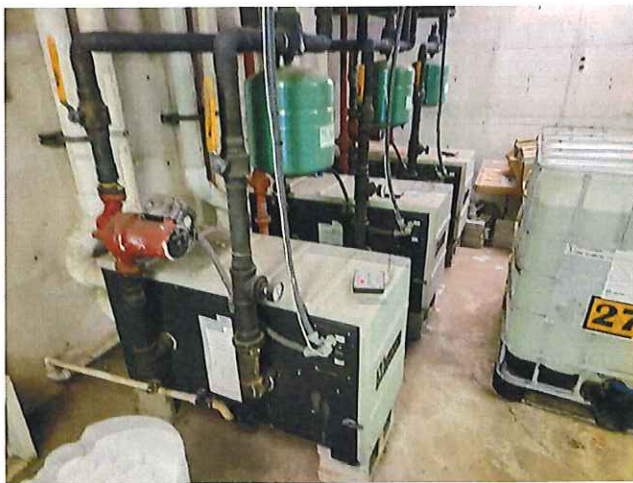
- *Pool Heat Exchangers:* There are three boilers that appear to be in good condition and are connected to two heat exchangers that is heating the pool. See photo 32.

32. THREE BOILERS

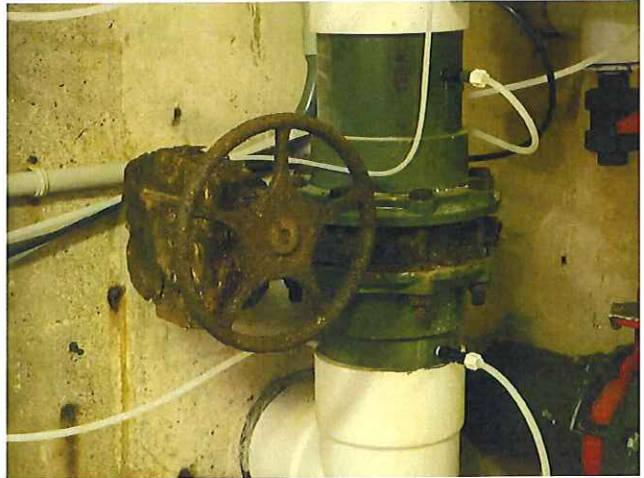
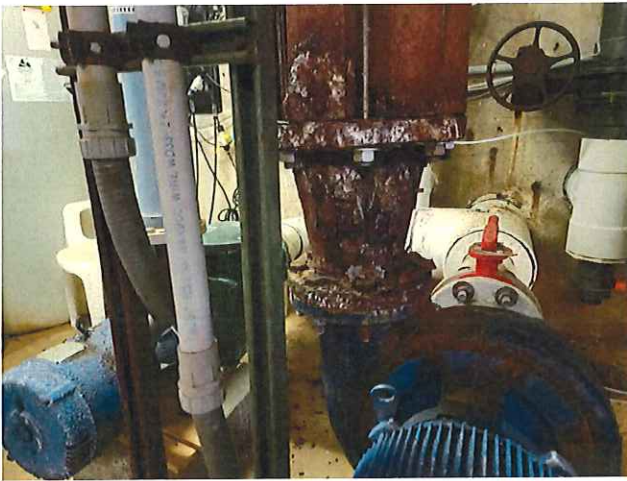
Visually there is severe corrosion present on all metal components in the mechanical room. The corrosion should be removed as necessary and equipment that can't be treated should be replaced as needed. See photos 34, and 35.

34. CORRODED VALVE

35. HEAVILY CORRODED REDUCER

3. Corroded Metal Components in the Mechanical Room
 - a. Ramaker recommends that all metal components showing signs of corrosion be replaced. This includes but is not limited to the following:

- i. Electrical boxes and panels.
 - ii. Water supply piping for the bathhouse.
 - iii. Metal piping out of the pumps.
 - iv. Pipe hangers.
4. Replacement of bullnose tile

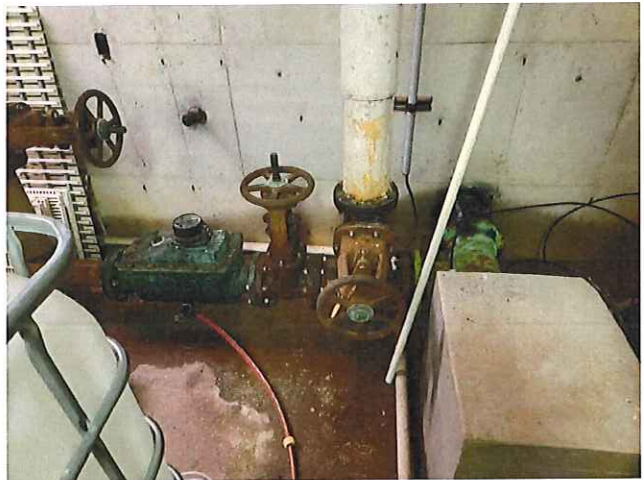
The supply water assembly train is located behind the chemical storage tanks in the mechanical space and is severely corroded. This should be replaced to prevent the system from failing. See photo 36.

36. CORRODED BATHHOUSE WATER TRAIN ASSEMBLY

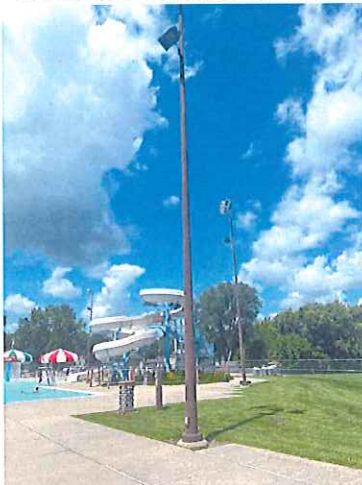
The pool facility has six light poles around the pool vessel that provide illumination for nighttime swimming. The light poles appear to be in good condition and Berlin staff desires to update the lighting to LED bulbs. For outdoor facilities according to DSPS code, the lighting shall provide a minimum of 3 footcandles of illumination at the water surface and on the decking. See photo 37.

37. POOL AREA LIGHT POLE

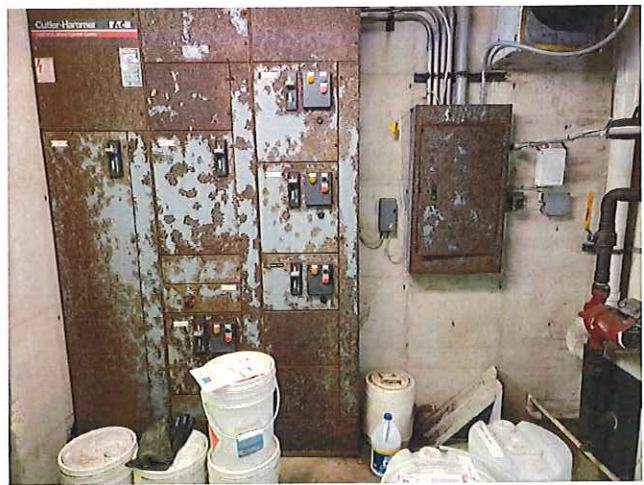
The entire electrical system for the pool facility is located in the pool equipment room below the pool deck. Due to proximity to the chemicals, there is severe corrosion present on the panels and boxes. See photo 38. No concerns were expressed to Ramaker by facility managers at the time of site visit. Continue to monitor and maintain electrical systems to ensure all equipment functions as needed when required.

38. CORRODED ELECTRICAL SYSTEM IN MECH ROOM

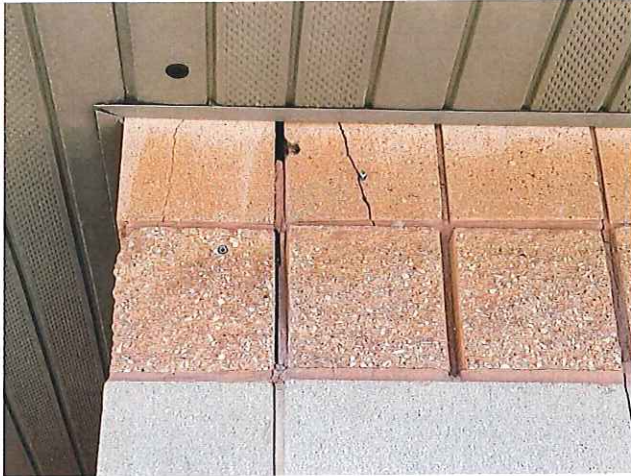
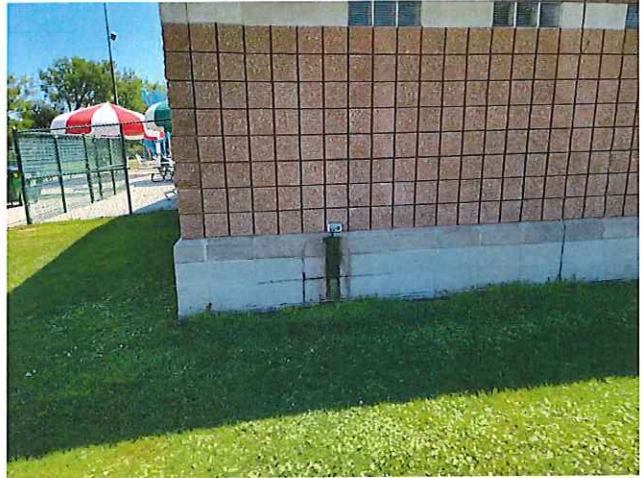
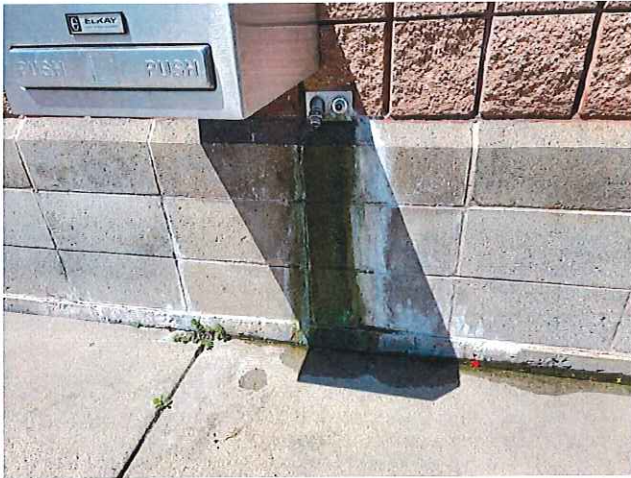
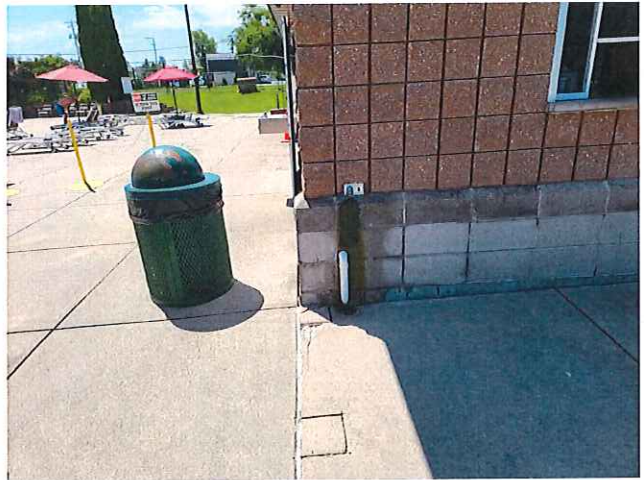
The Concrete Masonry Unit (CMU) walls of the building's exterior and interior are in good condition with no major structural deficiencies observed. There are a couple cracks at the exterior CMU with some separation at the mortar joints, see photo 39. There are instances of mineral deposits on the CMU below water bibs, see photos 40, 41, and 42.

39. CRACKS AND SEPARATION OF CMU

40. MINERAL DEPOSITS AT WATER BIB

41. MINERAL DEPOSITS AT WATER BIB

42. MINERAL DEPOSITS AT WATER BIB

6. Building Exterior
 - a. CMU cleaning at hose bibs.
 - b. Repointing CMU at cracks and replacing broken glass block.
 - c. Wood material will need typical wood maintenance, such as cleaning, replacing boards as needed, prepping for finish, and applying a finish.

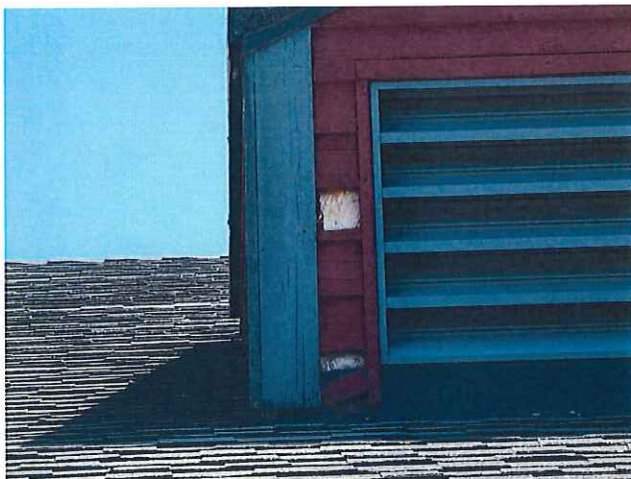
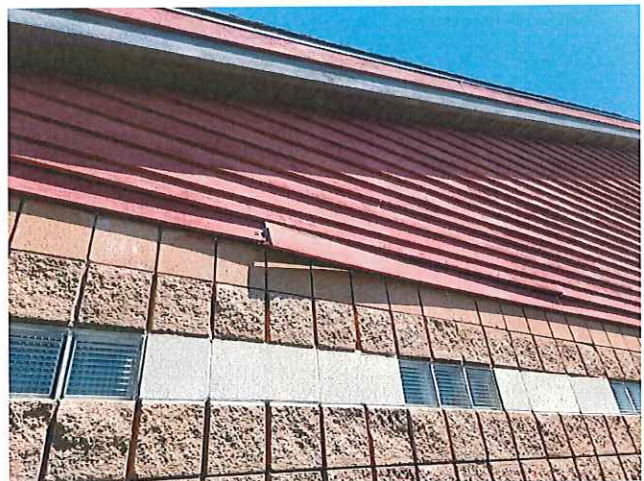
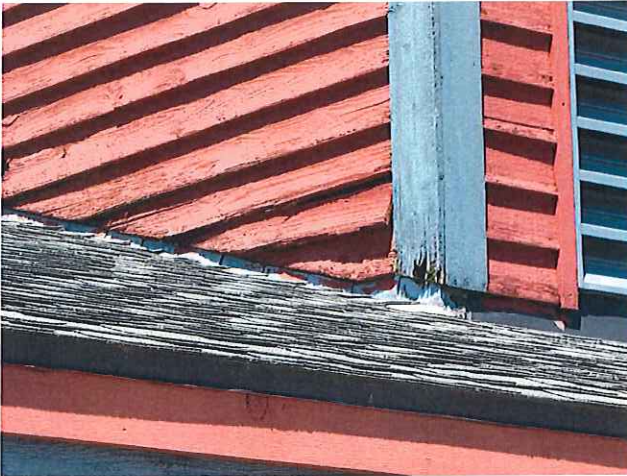
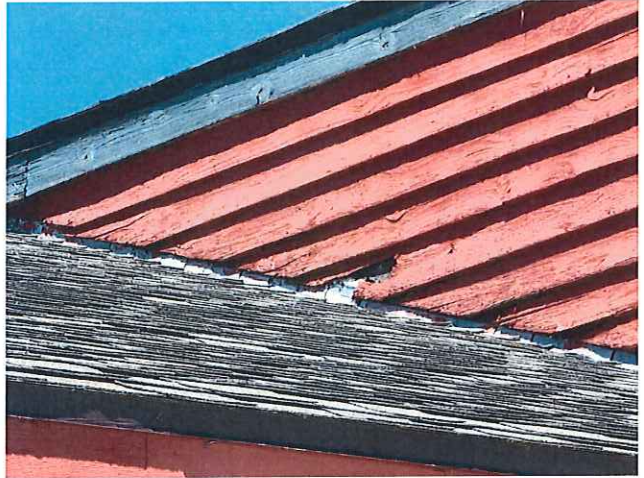
The wood siding above the CMU appears to be in fair condition with a couple instances where the siding is deteriorating and not attached correctly or missing, see photos 43, 44, 45, and 46. The wood fascia board has areas where the wood is also deteriorating, see photos 47, 48, and 49. The paint is peeling at the Men's and Women's poolside entrance soffit. Wood siding, wood fascia boards and wood soffits will need continued typical wood maintenance of cleaning, replacing boards as needed, prepping for finish, and applying a finish.

43. MISSING WOOD SIDING

44. WOOD SIDING NOT ATTACHED

45. WOOD SIDING DETERIORATING

46. WOOD SIDING DETERIORATING

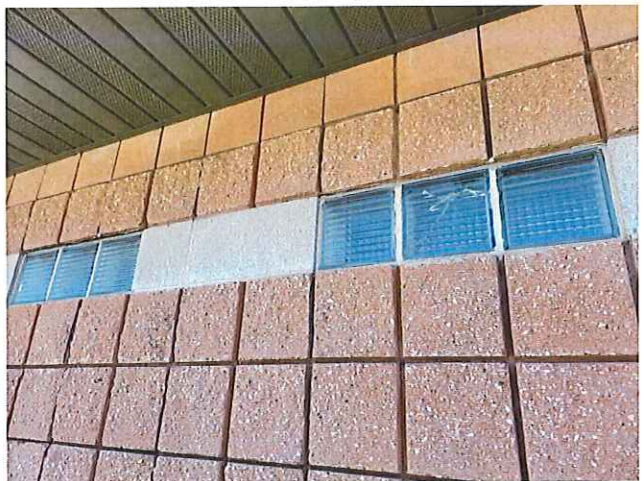
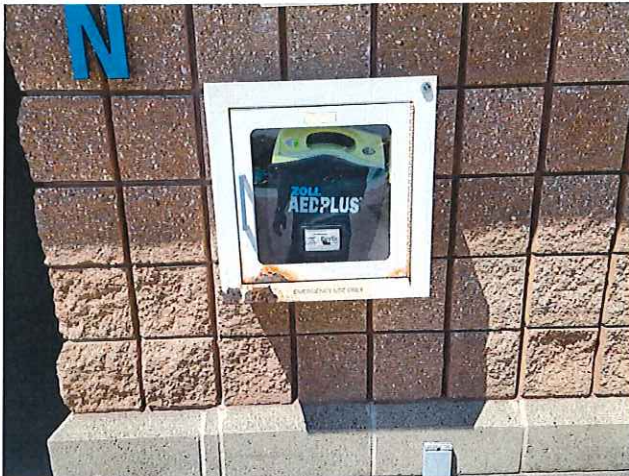
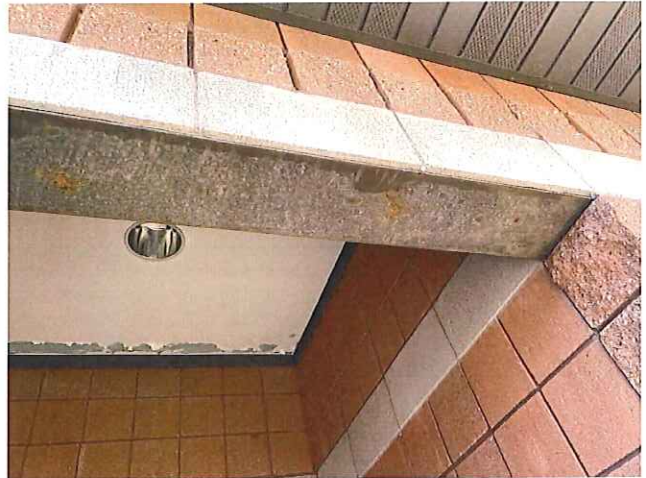
The exterior doors have some rust at the bottom of the doors and frames but otherwise seem to be in good condition. There are glass block windows in the exterior masonry wall with one broken glass block, see photo 50. The louvers throughout need cleaning. The AED cabinet is corroding along with a couple lintels, see photos 51 and 52.

50. BROKEN GLASS BLOCK

51. CORRODED AED CABINET

52. CORRODED LINTEL

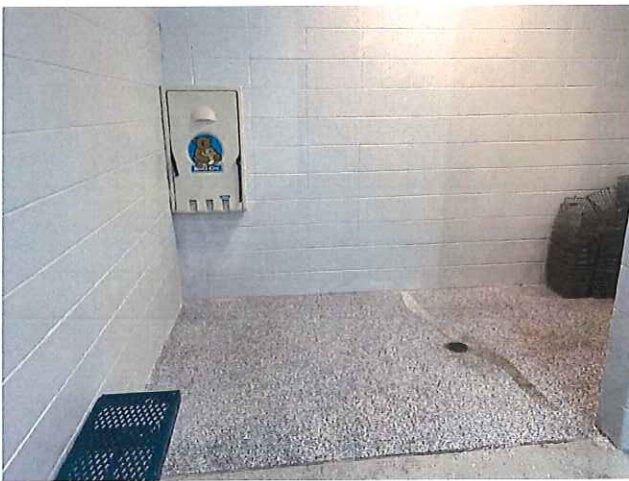
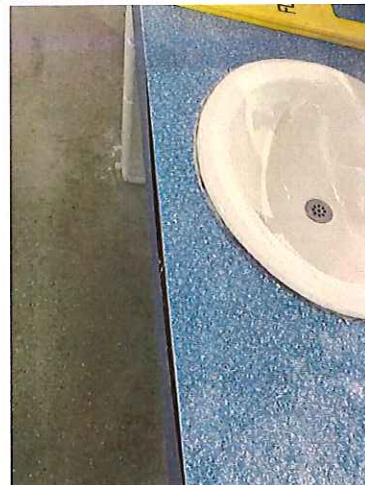
The floors throughout the bathhouse locker room and staff rooms are epoxy finished concrete, with signs of wear and tear. There is a significant crack observed at the women's poolside entrance, see photo 53. The CMU walls on the interior are painted and have mineral deposits and dirt built up throughout and towards the bottom. The wood wall finish above the CMU walls and wood ceiling boards are in good condition with some discoloration around the sky light. This may be an indication that there is or was water leaking, see photo 54. The painted ceilings in the Men's locker room show signs of damage and was repainted at some point, see photo 55. The countertop in the Women's locker room is delaminating, likely due to the presence of moisture, see photo 56.

53. CRACK IN FLOOR

56. DELAMINATING COUNTERTOP AT WOMEN'S LOCKER ROOM

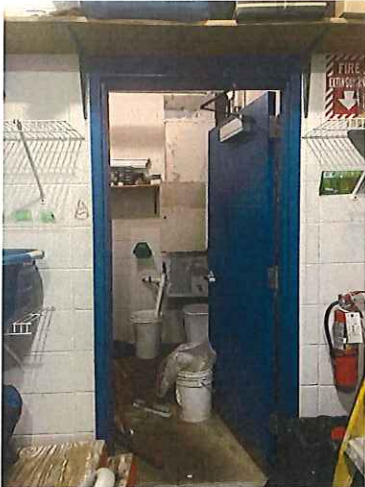
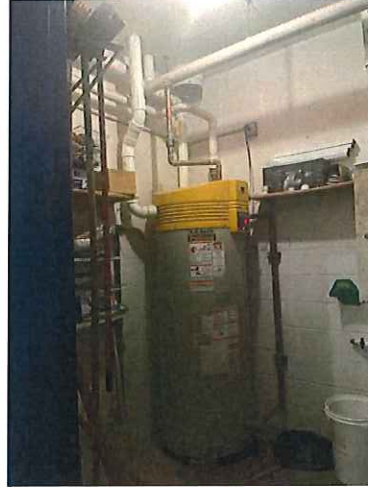
The equipment in the mechanical room is difficult to get in and out for winterization. There are three single flush doors for equipment to travel through, see photos 57 and 58. The door hinges could be replaced with offset door hinges to increase the width of the door.

57. MECHANICAL ROOM DOOR
